# CASE STUDY ON STRUCTURAL REHABILITATION OF A DAMAGED WING OF A BUILDING, IN ORDER TO CHANGE DESTINATION

**Abstract:** *This paper presents a case study made on an existing building, with reinforced concrete frames as structural resistance system and masonry walls, which have obtained an advanced state of degradation. The proposed consolidation solution leads for obtaining a seismic insurance degree that fits the requirements imposed by the P 100-2006 normative.*

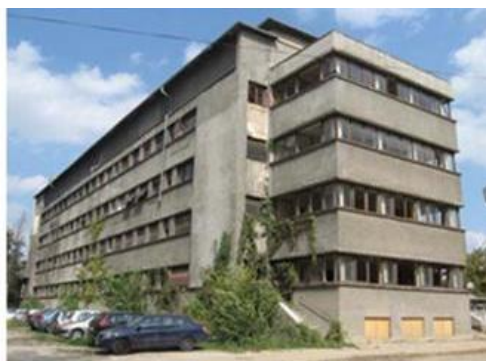
The case study presented in this paper was made on a building of a hospital in conservation due to the advanced state of degradation acquired over the time, Figure 1 and to which is assigned a new function: as “Research Center”, Figure 2.

Fig.1. The building before rehabilitation

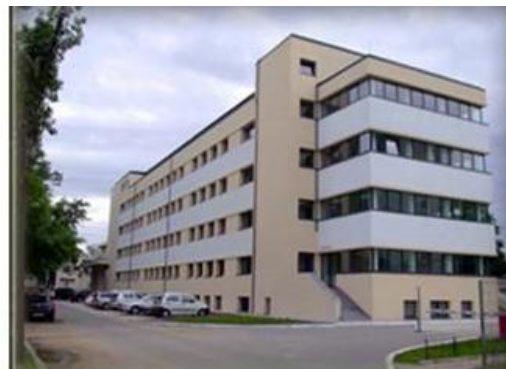
Fig.2. The building after rehabilitation

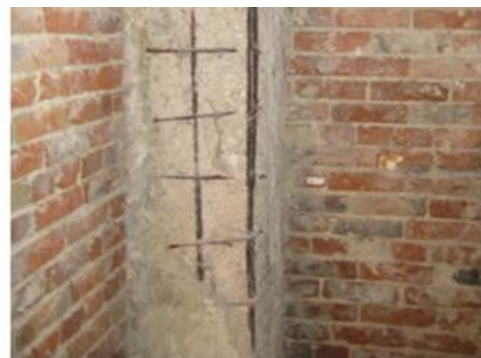
The concrete marks (in columns), established instrumentally and utilised in calculations is C 12/15 (B200).

Aspects regarding the state of concrete in structural elements is showed in Figures 3,4. The elasticity module taken in calculations is 240000 daN/cm<sup>2</sup> (corresponding concrete mark). (fig. 3)

Fig.3. An existing pillar , at the basement of the building.

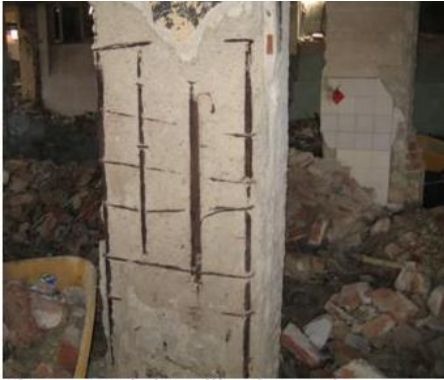
Fig.4. An existing pillar damaged

The multiple degradations are embodied in cracks on the mains directions of the building to brick walls, peeling plaster on the walls from the contact areas with concrete frames and peeling walls of the mesh formed by the frame (fig. 5). But it wasn't seen cracks in reinforced concrete frames (fig. 4, fig. 6), which means that energy dissipation was made by degrading the masonry, which means that the concrete reserves of strength are not consumed.

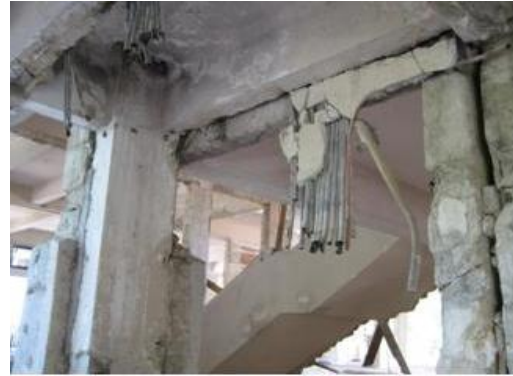
Fig.6. A deteriorated frame of reinforced concrete

The visual inspection of buildings has showed the existence of multiple degradations due to seismic movements and vandalism in recent years. Figures 5,6.

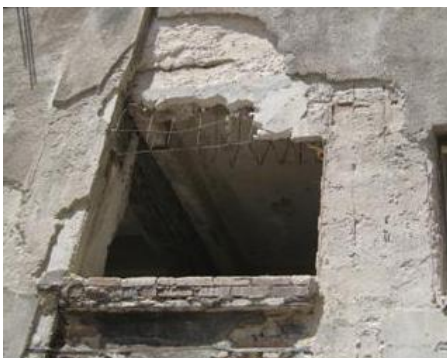
Fig.5. A deteriorated wall

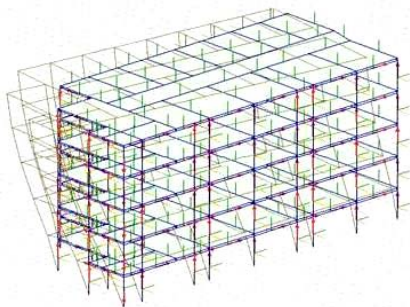
- The relative displacements of the level are 4,55 % for the N-S direction and 3,64% on the E-W direction, closer to the actual behavior of the structure as seen on the ground, Figure 8.

Fig.8. The lateral displacements of the building, according to the structural analysis program AXIS

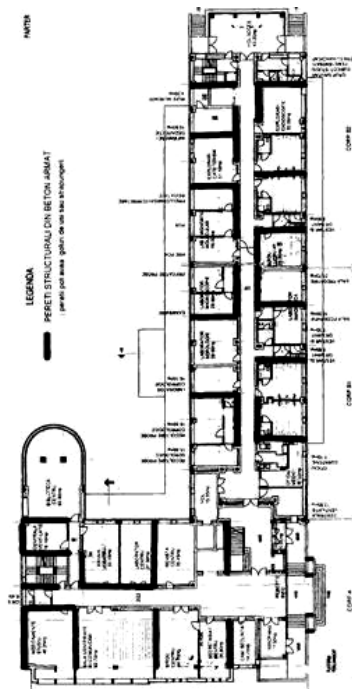
Fig.9. The displacements of the concrete walls that are used for consolidating the building

Consolidation will be done by introducing instead of some existing brick walls of concrete walls, with their own new foundations (Fig. 9).

Concrete walls will have a thickness of 15 cm and will be made of concrete B300 (C18/22,5). Their route will be between the existing concrete columns.

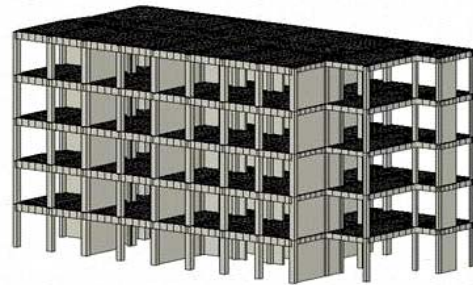
Fig.10 The wing B1 after introducing the concrete walls that are used for consolidating the building

In order to establish the fulfillment of the degree of insurance against seismic actions, it was used the structural analysis program AXIS, as it was used in the first case (point 2.2), but taking into account that the structural system is changed, by introducing the reinforced concrete walls (Fig. 10).

- Periods of vibration of the building for vibration mode I are 0.20 sec in the N-S direction, 0.24 sec. E-W direction and 0.18 sec. general torsion mode I.
- The relative displacements of the level are 1 % for the N-S direction and 1,60 % on the E-W direction.
- The  $S_{cap}$  value in this situation (defined as the ultimate performance) is 75692,62 daN, which leads to a degree of nominal seismic assurance of  $R = 1$ .
