Diagnosis of the Unit Injection Pump's Elements

Abstract. The paper presents the experimental and technical steps for diagnosis and optical investigation of the unit injection pump's elements for light and heavy diesel trucks, in order to establish the causes of malfunctioning and decision of replacing and/or repairing them. There will be presented some of the most usual damages and technical explanations and interpretation of the diagnosis tests.

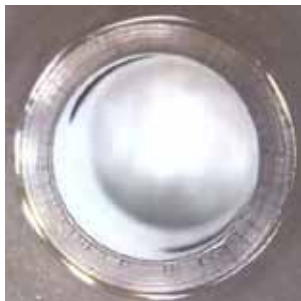
Fig. 4. Valve seat erosion

The faults identified on the valve-seat assembly of the six UIP, through microscope visualization, were similar and consist of many erosion marks caused, most probably, to the impurities in the fuel and compromising of the fuel filter, due to long time exploitation between changes. Thus are presented images captured on valve seat, Fig.4, valve, Fig.5, and valve pin, Fig.6, respectively, with the erosion spread marks on the jointed surfaces (in these pictures the parts were separated, after dismounted, for direct investigation).

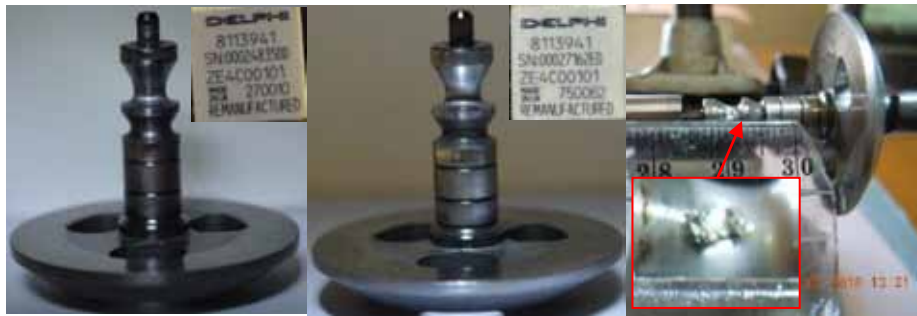
**Fig. 10.** Valve EUI 1**Fig. 11.** Valve EUI 2**Fig. 12.** Valve EUI 3

EUI	T1 [bar]	T2 [10 s]	T3 [s]	Valve Figure	Observations
1	335	yes	10.5	Fig.10	stuck nozzle
2	342	yes	5.2	Fig.11	stuck valve
3	341	yes	1.3	Fig.12	unidentified small part
4	339	yes	1.35	Fig.13	
5	342	yes	2.5	Fig.14	
6	339	yes	1.7	Fig.15

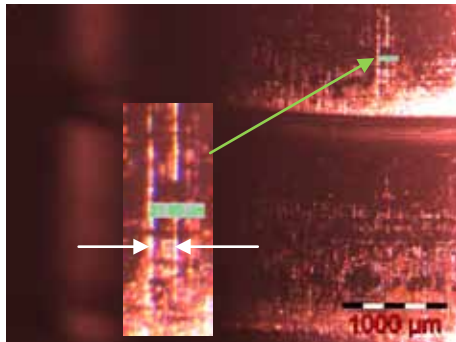
Fig. 18. Valve pin micro groove

Thus it was necessary supplementary investigation on the internal damages of the hydraulic assembly of the EUI that were performed on the stereo microscope. The visualization of the corresponding joint surfaces reveals pronounced erosion marks (micro grooves, Fig.18 and micro abrasive marks Fig.19) on the high pressure valve liners and pins, all of these as consequences of the impurities in the fuel or compromising of the fuel filtration. Were excluded the inappropriate material quality because on these surfaces were not identified point-size regions where pitting occurs and also there was no thermal hardening or chemical treatment of these surfaces applied.

The micro groove presented in Fig.18 reveal the action of some abrasive particles (the dimension of the groove is 21.96 µm, see details in Fig.17) which generate axial wear on material and Fig.19 present the spreading of the wear surface to up to 35 – 45% of the lateral surface of the sealing/joint surface of the valve, that generate the inappropriate working conditions of the whole EUI. Due to these advanced erosion of the valve liner – valve pin joint, for all the EUIs, the high pressure “sealing” are compromised, the leaks and pressure drop are high and the EUI were rejected by the Hartdrige testing equipment, and the only possibility too fix the claims of the malfunctioning of the engine is to replace all these EUIs.

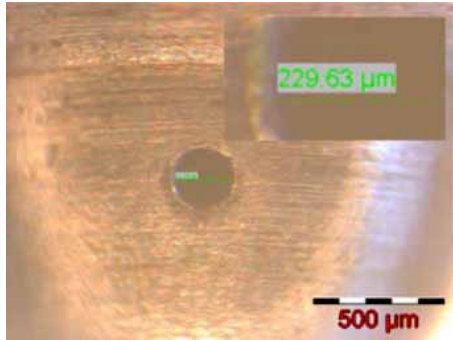
Fig. 20. Measured nozzle's hole

In the same time, for all the six injectors visual analysis was performed, on the stereo microscope, to identify possible alteration of the nozzle's holes. For each of the fifth holes of each nozzle the optical measured dimensions, using an internal light source (see Fig.21) were in the 220 – 240 μm range, Fig. 20 and 21. According to this visual inspection were observed compromising of the nozzle's surface and was established that these defects occur as consequences of the steel-brush cleaning of the injectors, in order to remove the soot and unburned hydrocarbons deposits on EUI.
