INTERNATIONAL SCIENTIFIC CONFERENCE

CIBv 2010

PROPOSAL FOR THE REHABILITATION OF AN OLD STEEL BRIDGE AT DUMBRĂVENI, COUNTY SIBIU

Abstract: This paper presents the study of an old steel bridge in Dumbrăveni over the Târnava Mare River, in order to rehabilitate it. The structure was recalculated taking into account the technical condition of the bridge and the actual traffic as well. Finally, a pleading is made for maintaining the over 80 year old historical bridge and several proposals are being formulated for the rehabilitation.

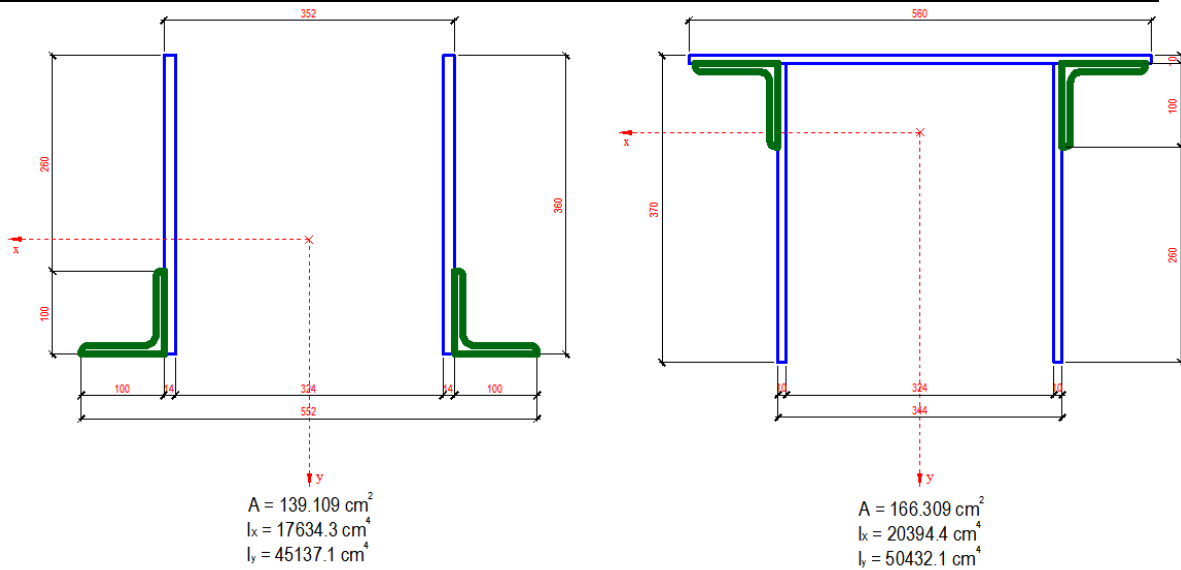
The main girders of the superstructure consist of truss girders with parabolic chords. The transverse distance between the main girders is 6.41 m. The lower chord has two 360x14 webs and two L 100x100x10 angle profiles. The upper chord is made of two 360x14 webs, two L 100x100x10 angle profiles and a 560x10 flange. (Figure 5)

Fig. 5 Cross section – lower chord and upper chord

The allowable stress according to the standards, for load case 1, is $\sigma_a=150 \text{ N/mm}^2$. The values of the stresses in the upper chord exceed the allowable stress; therefore the bridge is not to be crossed by these convoys.

It is to be mentioned, that with minimal reparations (introduction of supplementary angle profiles on the upper chord of the main truss girder) can improve the bearing capacity, assuring the crossing of the A30 convoy.

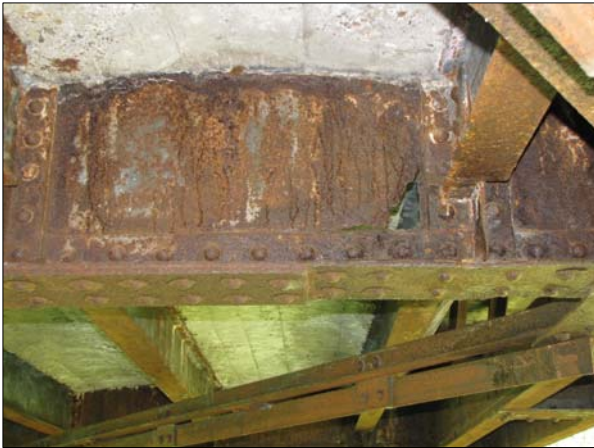
Least affected were the elements that allowed the drainage of the water – the struts and the diagonals. The most affected structural elements are the lower chords, the stringers and the cross girders.

Fig. 8 Corroded cross girder

- Unveiling of the concrete plate
- Sandblasting of the structure
- Changing of the high corroded elements
- Realization of on concrete plate with a composite concrete-steel effect

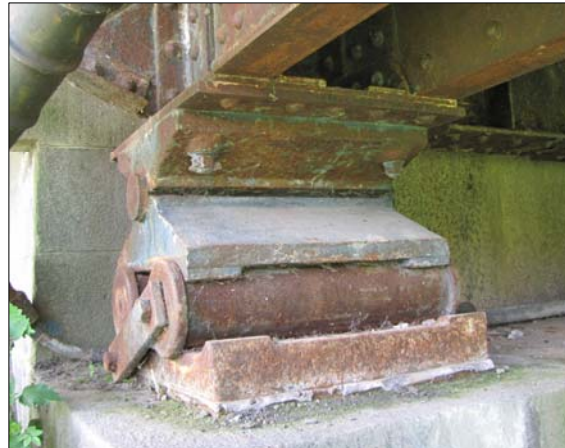
Because of the insufficient maintenance over time, bearing devices are also blocked by rust and other impurities (Figure 8 and 9).

Fig. 9 Bearing device
