FAULTS FOUND IN SEWER PIPES, CAUSES AND REMEDIES

T. V. CHIRA¹

Key words: *sewer pipes, faults, CCTV inspection, pipe rehabilitation.*

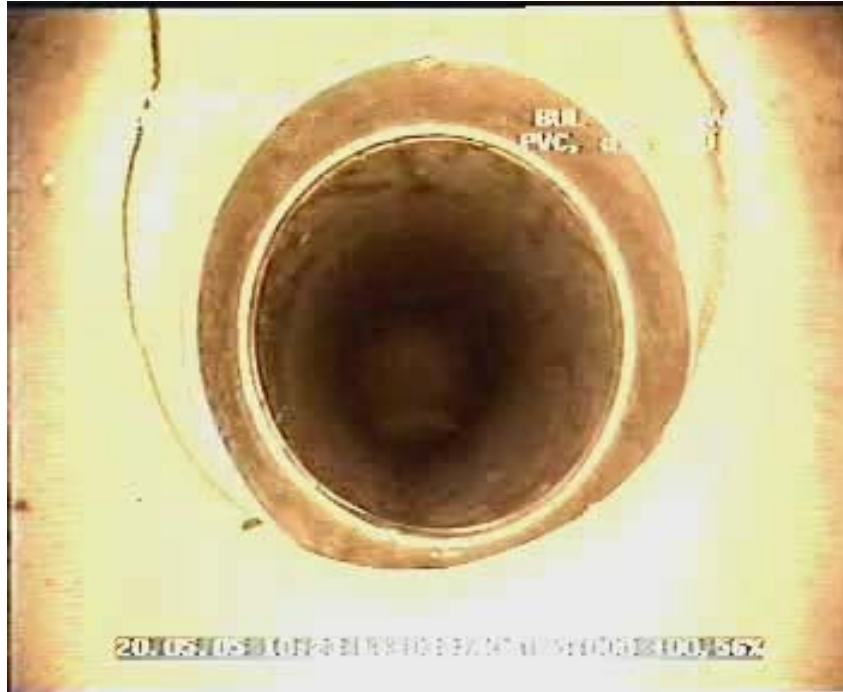
This may lead to cross sectional shearing of the pipe when big loads are applied on the less compacted portion of the soil. Shearing is possible also in case of landslides. In other circumstances it's possible to have less compacted soil on the sides of the sewer main and when the laterals are loaded heavily they could break the mains wall at the joint. Figure 1 presents such a case. Cracks or breaches could also be caused accidentally during interventions on other networks adjacent to sewer by digging machinery and equipment, especially when the sewer section is older and less well documented. By implementing modern tools for network mapping and documenting like GIS (geographic information system) we should be able to avoid in the future these incidents. Sometimes the cracks are caused by increasing loads combined with aging of sewer infrastructure. In most cases the sewer lines are underneath roads circulated by heavier and numerous vehicles. In these cases longitudinal cracks appear on the upper side of the pipe and if the reinforcing is exposed the pipe will collapse when it corrodes.

Fig. 1. *Cracks in the wall of a PVC sewer main at a lateral joint due to uneven soil compaction and the lateral acting as a lever*

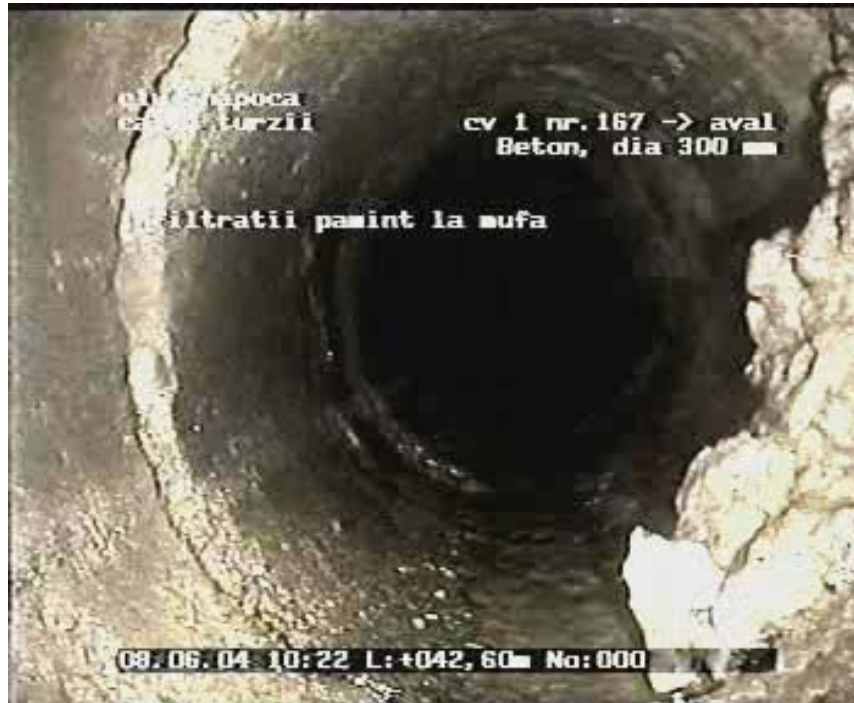
There are several types of faulty joints. In some cases, when the sealing is done with rubber gaskets the sealing is lost because when the pipes are connected they are not properly aligned and the gasket is expelled from its groove. This mainly occurs in PVC and GRP sewer sections. Another reason for gasket expulsion is the lack of a proper lubricant on the entire length of the gasket. In other cases when the sealing is done with mortars or other compounds in time they fall from the joint and the sealing is lost. Obviously, these faulty joints are big sources of infiltration of ground water or exfiltration of waste water. In Figure 2 a faulty joint in a concrete pipe allows soil to get inside the pipe and in Figure 3 a

Fig. 2. Faulty joint in a concrete sewer section allowing soil to enter inside the pipe (in the right side of the image)

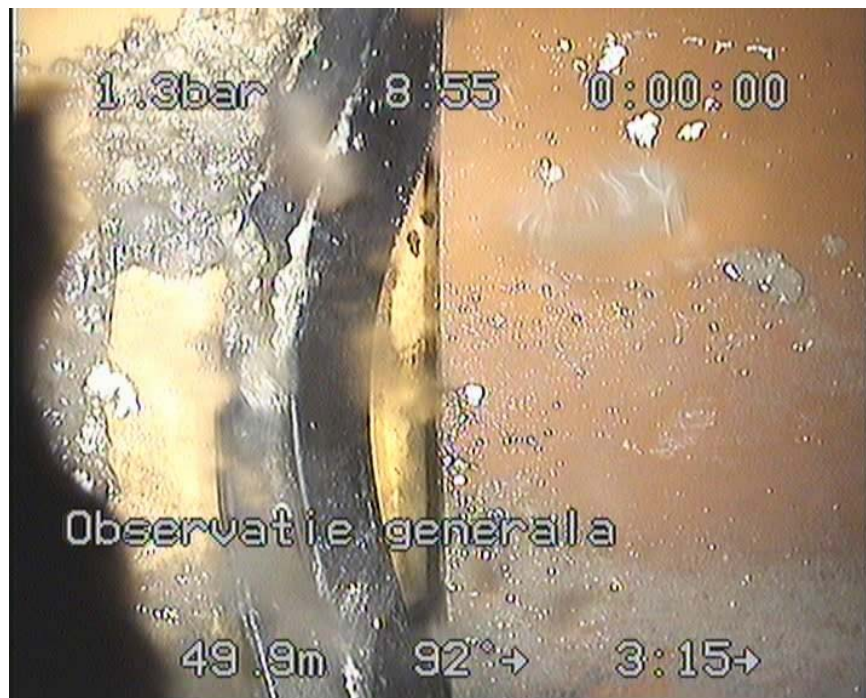
Fig. 3. Rubber gasket expelled from groove in a PVC pipe joint

joint has the gasket expelled and sealing compromised

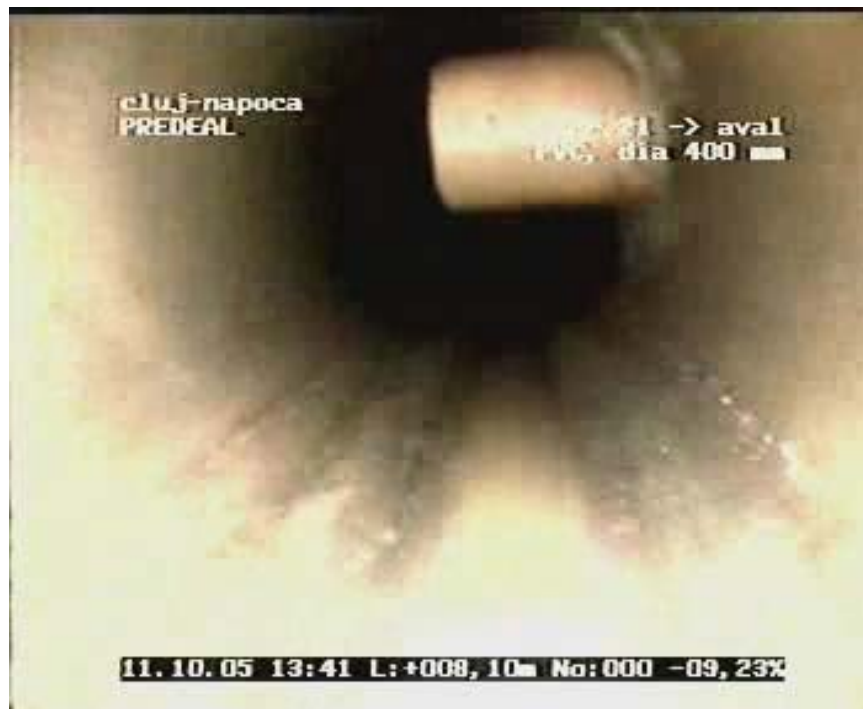
The same problems may occur also at lateral joints but here there is one more situation worth mentioning, namely laterals protruding excessively inside the sewer main. In this particular case is not an issue of compromised sealing but an issue of creating an obstacle in the way of floating debris that may lead to creation of dams inside the sewer section. For example a wooden plank stuck against such a protruding lateral will quickly agglomerate sand and gravel thus creating a sediment deposit and diminish the usable cross section of the pipe. Another issue related to protruding laterals is the impediment of continuing the CCTV inspection when such a situation arises because it acts like a barrier in the way of the inspection robot, the only solution being to try to insert the robot from the

other manhole and this is time consuming. This situation is exemplified in Figure 4. Even more, if we have two protruding laterals between two consecutive manholes the distance between them cannot be inspected.

Fig. 4. *Protruding lateral inside sewer main prevents the camera robot to advance along the pipe [2]*

as possible because thickening of the roots may lead to pipe collapse. There are special cutting heads for removing roots inside the pipe but the tree should also be removed from the vicinity of the pipe line. Protruding laterals can be removed by remote controlled robots equipped with special cutting heads. Minor cross sectional deformation should be inspected on regular bases to see if the deformation is getting worse, in which case the pipe must be replaced. Sever deformation implies immediate replacement of the pipe.

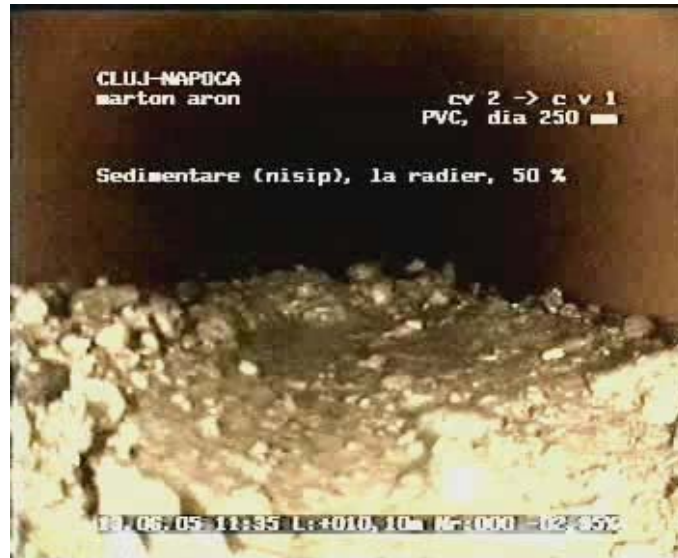
This type of fault has mainly two causes. The first and the most frequent is the lack of a proper pipe slope that leads to a waste water velocity lower than the self-cleaning velocity stipulated by norms. The second cause is the creation of artificial dams inside sewer pipe due to debris stuck across the section. The most problematic is the first case because it can be corrected only by remaking the sewer section and laying the pipe at the correct slope. The alternative, would be to make frequent washes of the sewer section which can be very costly in terms of money and resources. The second situation can be solved comparatively easy by removing the dam inside the pipe

Fig. 6. *Deposits of sediments – 50% of the pipe cross sections is unusable due to sediments*

and performing a wash of the sewer section. In cases of counter slope the deposits of sediments can reach such heights that render the sewer section unusable.

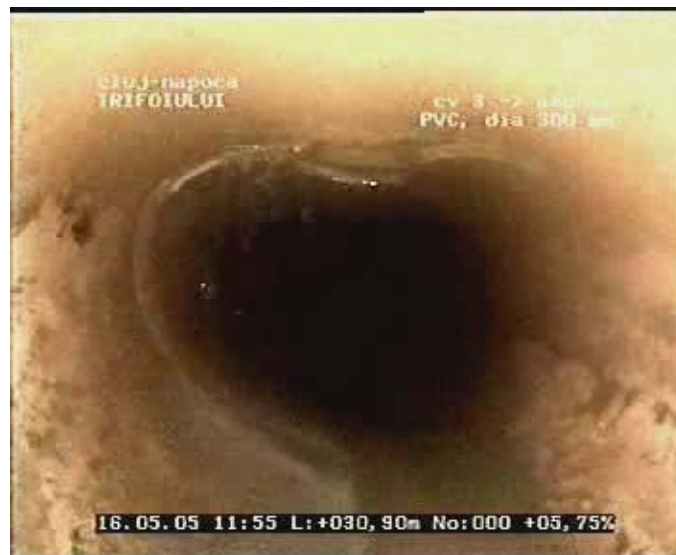
While small ovalities do not affect the functioning of the sewer section as long as the sealing is still maintained severe deformation can go beyond ovality and the cross section of the pipe gets a U shape. In

this case it is obvious that the good functioning of the sewer is prevented and the sealing is lost. Figure 6 shows a case of sediment deposit and Figure 7 presents a case of severe cross section deformation in a PVC pipe.

Fig. 7. *Severe deformation of the pipe cross section – the sealing is compromised*
