3rd International Conference
"Advanced Composite Materials Engineering"
COMAT 2010
27- 29 October 2010, Brasov, Romania

FAILURE ANALYSIS OF A GLASS FIBER REINFORCED THERMOPLASTIC AUTOMOTIVE PART

S.Ferrándiz Bou, J.LópezMartínez, Francisco Parres, Raúl Navarro

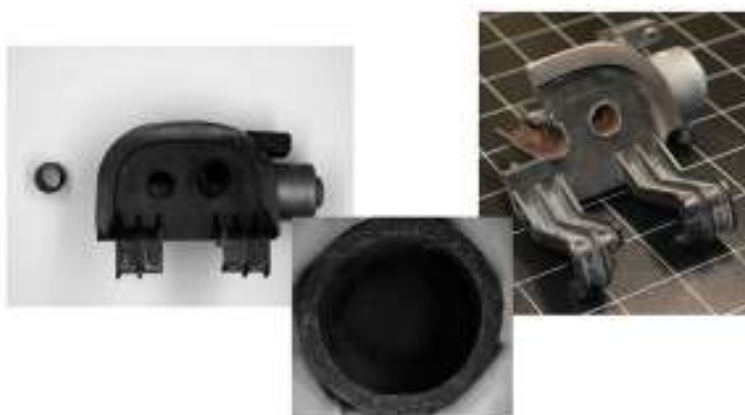
Firstly we started with a visual study of the part in order to present a hypothesis of the break causes. Figure 1 shows the break of one of the connections between the valve and the refrigeration system. The microscopic study of the break in this connection indicates that a fragile break has occurred where no type of deformation could be found in the plastic originally.

Figure 1: Break brittle part

In the image, small glittering specks can be seen in the fracture which are present due to the use of the glass fiber to improve the mechanical properties of the polymer. The observation of the part poses possible causes of the fracture [6], the break could be caused by a fault in the material such as degradation phenomenon in its environmental surroundings or the effect of refrigerating liquid that passes through the part.

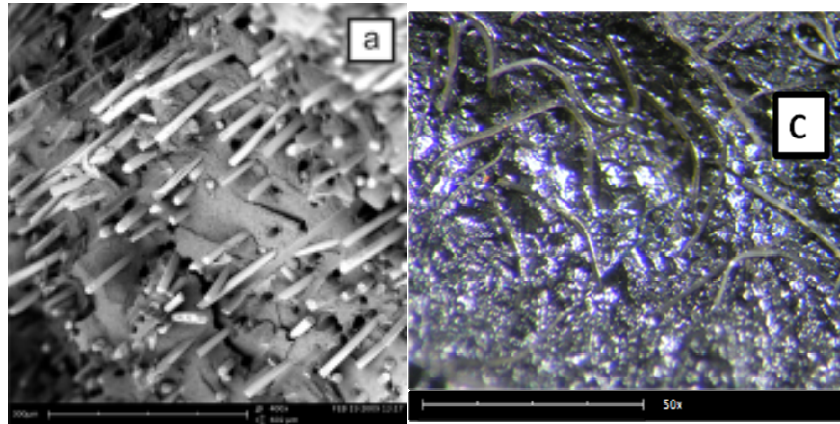
A correct and failure zone of fractured surfaces provides information about interaction of fiber and matrix. Failure and correct zones show significant differences. The failure surface zone shows low adhesion between glass fibers and matrix. We can see the fibers separated from the matrix (Figure 2).

Figure 2: Fiber adhesion in failure zone

A lot of parts has been designed to perform their function perfectly, but sometimes do not consider the effect of degradation phenomena under certain conditions. Fracture morphology analysis indicates a cohesion loss between the fibers and the polymer matrix, which indicates some degradation in the matrix. Injection simulation process and fiber orientation study allow us discard the piece design and injection process as failure origin. However, analysis techniques show significant differences between correct zone and failure zone. Enthalpy of fusion is used to observed degradation phenomena, although in this case are significant differences between the correct and failure zone. Moreover, the results obtained using the thermogravimetric analysis indicate that the degradation occurs in two phases, corresponding to Polyamide phase and another, later, Poly ethylene phenyl phase. These results corroborated that an increase of cyclopentanone in the failure zone. There is every indication that hydrolysis ageing of polyamide phase produce failure process.

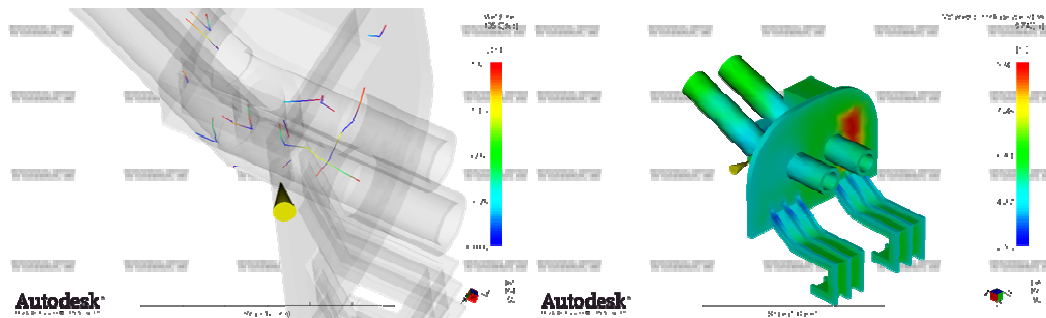
The next step has been the 3D simulation of residual stress and fiber orientation. The different simulation images don't show weld lines near of the failure zone, this is due to various slide existence. The piece design reduces the potential effect of welding line and air trapping (figure 3).

Figure 3: Weld lines and volumetric shrinkage

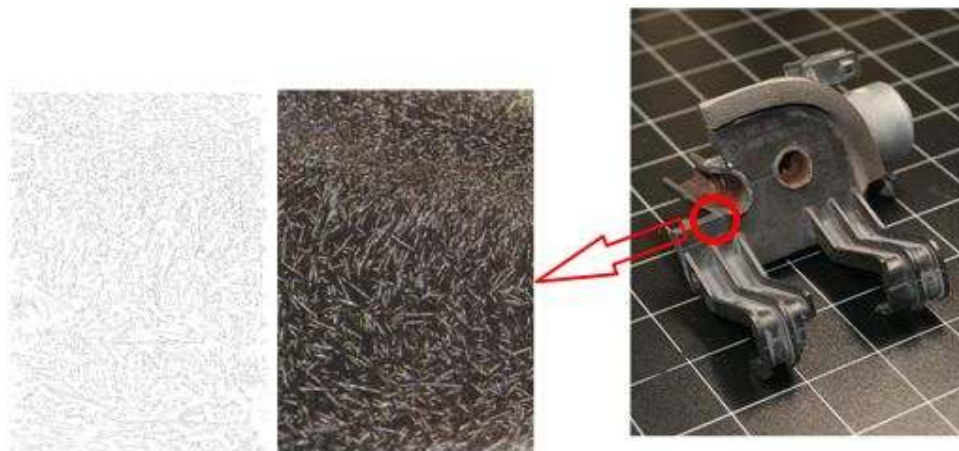
Additionally, fiber orientation study show normal parameters in orientation tensor values (Figure 4). To corroborate the results of the simulation we have prepared a sample of the failure zone using the method of Bay, RS [7]. The image analysis show typical fiber distribution in the frozen and core layer, where we can see fiber orientation in the flow direction for frozen layer and transverse orientation in the core layer. These results allow us discard the orientation fiber as a trigger for the rupture of the piece.

Figure 4: Fiber orientation

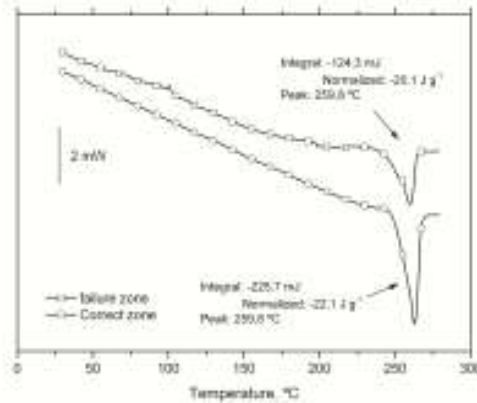
In order to observe differences in the area of the break, we analyzed the internal part (the part which makes contact with the refrigerating liquid) as well as the external part by using the above-mentioned techniques. Figure 5 shows the calorimetric curves in the analyzed zones (failure zone and correct zone), in both cases an endothermic peak corresponding with the fusion of the corresponding spherulites can be found along with the presence of polyamide in the polymer.

Figure 5: Comparative DSC of failure zone

On the other hand, the calorimetric study shows no significant differences in terms of the failure zone and correct zone, including the enthalpy fusion which is very similar in both zones (enthalpy energy: failure zone 20.1 J g⁻¹ and correct zone 22.1 J g⁻¹). The EPP has a vitreous transition temperature (T_g) of about 217 degrees celsius. If variations in T_g exist they are unobservable due to the presence of the PA fusion. The thermogravimetric curves show significant differences between failure zone and correct zone. The degradation process starts earlier in the fractured zone, where the values of the temperature of the beginning and end of the degradation are lower (T_{zi} = 350 °C -T_{zf} = 490 °C) that correct zone (T_{zi} = 390 °C -T_{zf} = 512 °C). By the other hand, failure zone show two jumps in the thermogravimetric curve which correspond with the thermal degradation of the materials which form the blend (PPE/PA-GF30). The first jump, which occurs at approximately 350° C and finishes at 440° C, suggest a loss in weight of around 35% in total. This first jump is associated with the PA thermal degradation [8](Figure 6).

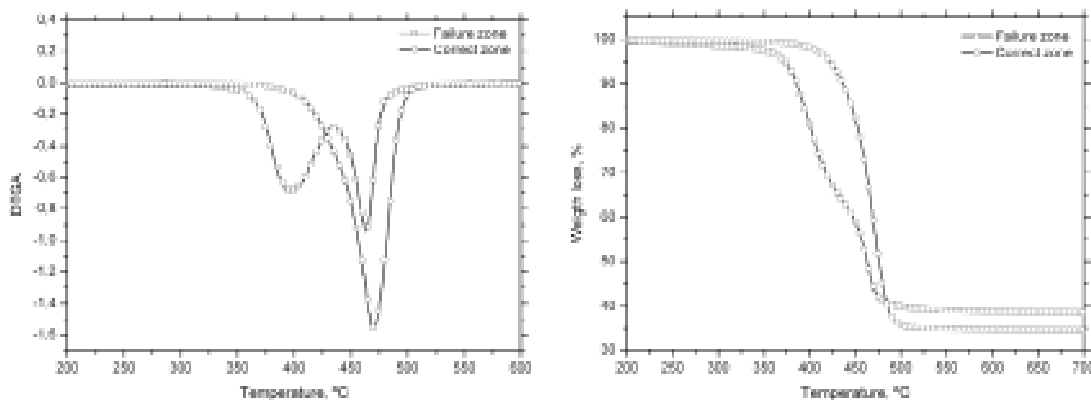
Figure 6: Thermal degradation

After this jump a second process of degradation is initiated associated with the PPE [9] which finishes at around 480 °C with a loss of 25%. At the end of the degradation, 40% of the weight is left which corresponds with the presence of glass fibre in the material, first derivative TGA curve show these phenomenon more easily.
