INTERNATIONAL SCIENTIFIC CONFERENCE

CIBv 2010

12 – 13 November 2010, Braşov

EXISTING CONCRETE SILOS – LESSONS FROM INSPECTION, DIAGNOSIS, REHABILITATION AND STRENGTHENING

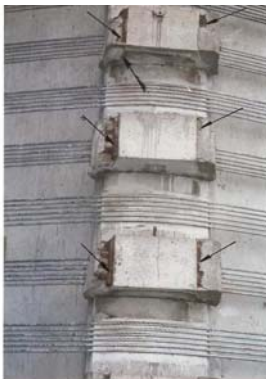
Fig. 3 Blocs examination

The results of inspection on the silos made after about 25-30 years of service showed that the prestressing system presented significant deteriorations due to the corrosion of strands and anchorages, which were similar in all four hexagonal cells batteries.

The next figures show various zones of intensive corrosion on the strands bearing support – fig. 5, at the strands exit from blocs – fig.4, the anchorages in blocs after removing the concrete protection – fig. 3, 6, 7, and 8.

Many of strands and / or anchorages showed an in-depth deterioration, that can strongly affect the safety of the prestressing system and of silo itself, as well as the safety in service. This led to the decision to replace the prestressing system so as to conserve the initial design service life.

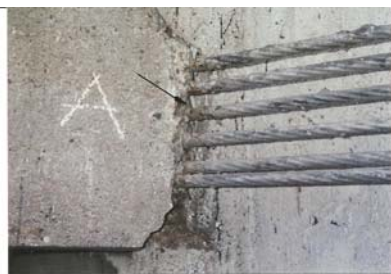
Fig. 4 Strands exit from blocs

- defective protection of strand at the exit from blocs and on the bearing zone; impossible application of coating behind the strands which practically remain uncoating;
- low quality, noncompact concrete for anchorages protection;
- use of hardened steel anchorages with a high corrosion sensitivity.

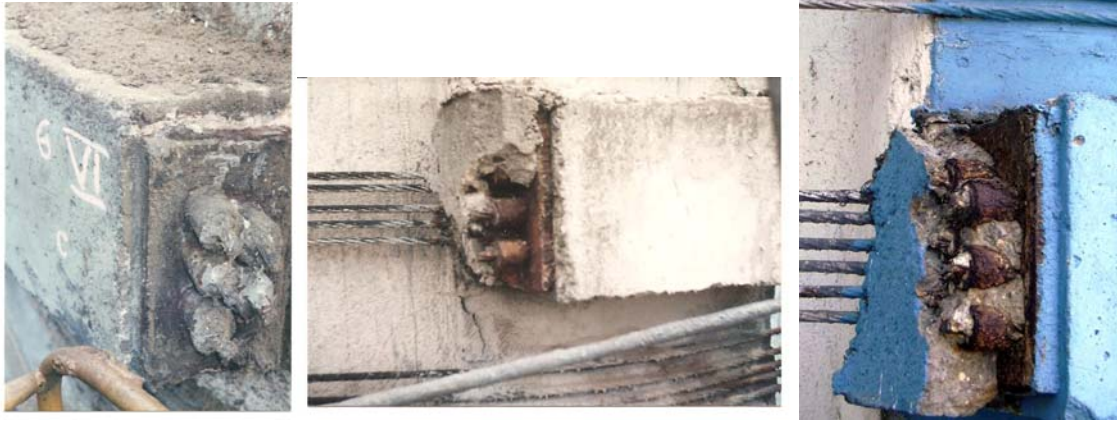
Fig.6 No sensible anchors Fig.7, 8 Anchorages with sensibility to corrosion (hardened only)

Behavior differences can be observed between the anchorages no sensible to corrosion – fig.6 and the anchorages more sensible to corrosion like in hardened steel only – fig. 7, 8.

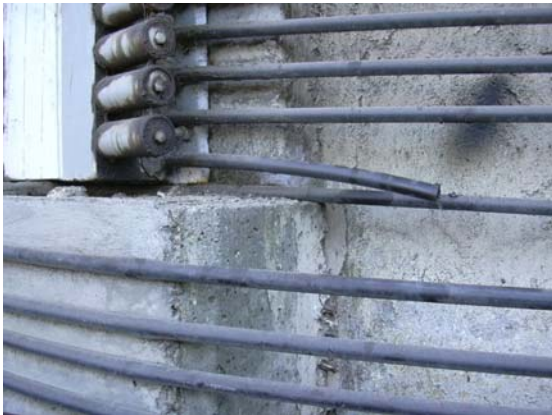
The in-depth inspection was performed in two cases after 3 or 5 years intervals from the replacement of prestressing, providing access along height of the wall. The inspection results showed a good behavior of the system – see fig. 11, 12, including anchorages leaning on bearing steel blocs and protected by sleeve nuts filled with grease.

An exception was found in a few local zones of tube hose connectors where a short movement of tube appeared due to temperature variation. The tube hose connectors were repaired.

Fig. 11 Actual view of strands in tube and anchorage sleeve nuts

It was recommended to carry on surveys, such as in-depth inspection, at 3 to 5 years intervals after the application of a substitute prestressing system.

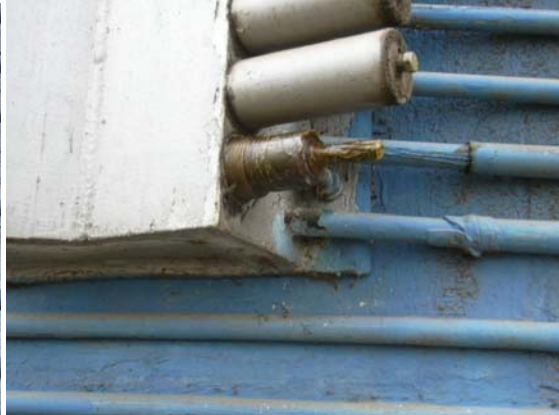
Fig.12 Grease state of anchorage after removing sleeve nut

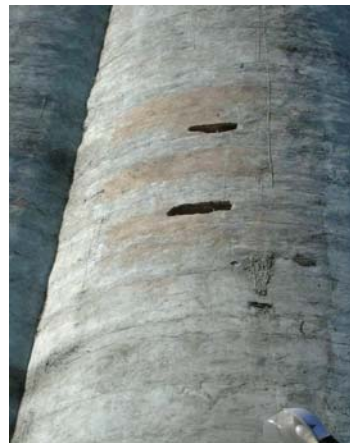
Multiple deteriorations, especially noted in one battery, mainly affected the concrete cells wall, having an advanced state of cracking and numerous deficiencies, such as lack of compactness, due to the slip form method of concrete walls construction.

Fig. 14 External cell surface before inspection

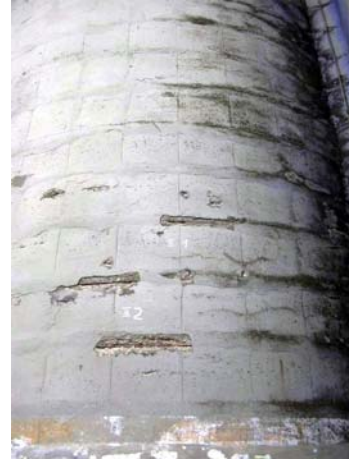
Fig.16 Deteriorations on external cell surface

The main deteriorations of this silo were observed to concrete and reinforcement on external cells surface only.

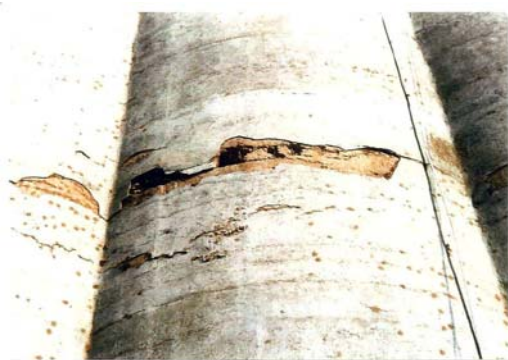
Fig.17 Deep deteriorations in concrete

The inspection showed deep deteriorations in concrete, multiple local small deteriorations, such as cavities, holes (some of them pierced), detached bars cover, inconsistent concrete, unfilled holes provided for slip form supporting bars – Fig.17, 18, 19, 20, 21.

Diagnosis of deteriorations: The slip form casting of the planned C16/20 class concrete in cells wall was unfortunately defective and the main concreting deficiencies were:

- portions of concrete cast-in place after setting strength started;
- local cavities or casting interruptions;
- segregation areas (lack of compactness), impurities.

So, for filling of all the cavities or holes, the concrete mix of concrete class C20/25 included aggregates of to 3mm or 7mm, an acrylic bonding agent to be applied on old concrete surface and a super plasticizer, so as the concrete vibrating became not needful. Other small deficiencies of the concrete, as well as of the reinforcement concrete cover, were repaired using epoxy bonder or epoxy concrete. The cracks exceeding 0.3 - 0.5 mm were injected using low viscosity epoxy resin.

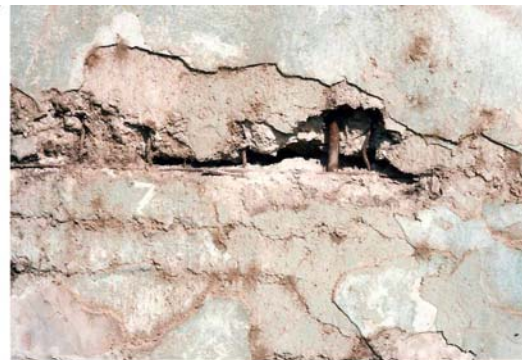
Fig.18 Detached bars cover, cavities

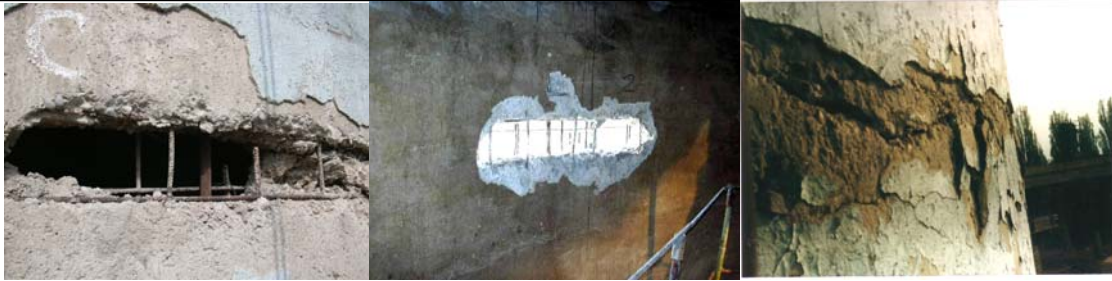
Fig.19 Hole, view from outside Fig.20 Hole, view from inside Fig.21 Deep damages in concrete

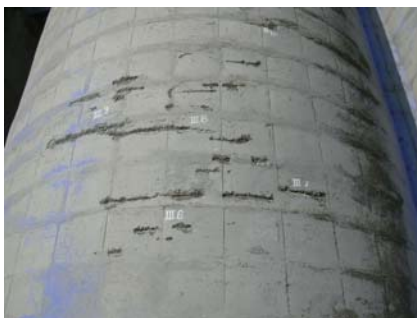
Fig.22 View of outside affected zones

- detachments of the reinforcement concrete cover ,where the thickness measured 5-15 mm;
- segregation areas;
- adherent or in-deep corrosion of the reinforcement in this zone;
- concrete deterioration due to freeze-thaw, see Fig.22, 23, 24 and 25.

These deteriorations were caused by the external weather action combined with an insufficient concrete cover of outside layer of the reinforcement and of concrete segregation.

For the repair of structural concrete we recommended different procedures using special, reliable chemical products, such as epoxy bonder or epoxy concrete and an outside concrete surface protection by impregnating it with chemical products supplied by SYMONS - DAYTON Corporation USA [6].

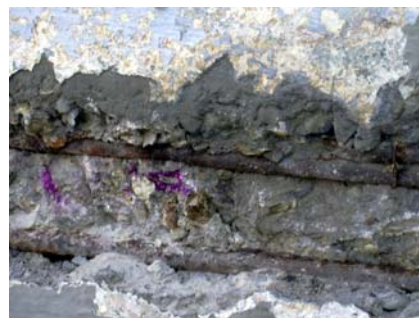
Fig.23 In-deep reinforcement corrosion

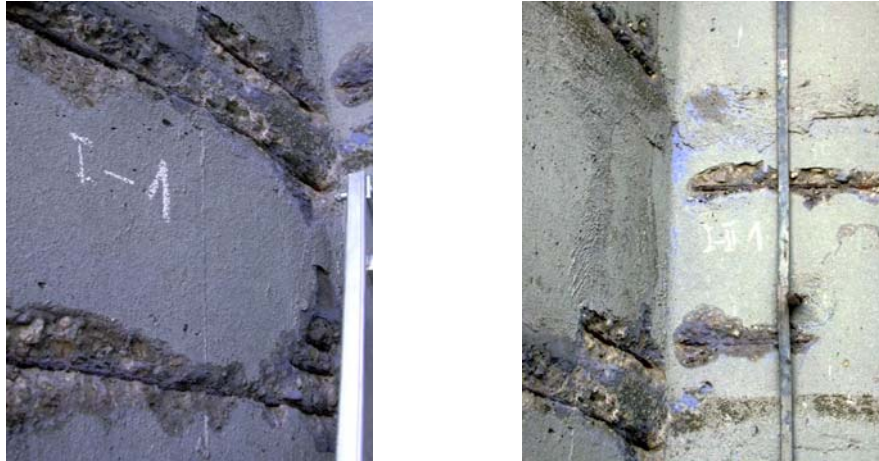
Fig. 24, 25 Expelled concrete in zone with reduced concrete cover
