# STUDY ON DURABILITY OF RESISTANCE HALL STRUCTURE CET GOVORA

**Abstract:** *The object of this study is the durability behavior of a r.c. structure in CET Govora. Investigation was made on: foundations, columns, beam and slabs component of turbo-unit servicing TA 4 between levels - 0.04 m and -3.50 m and axes 18 ... 23.*

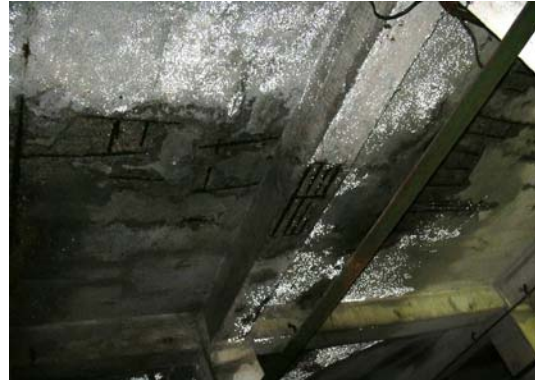
Specific technological equipment for '60s and '70s, were damaged in their operation. Thus, it is worth mentioning: on extended portions of the hall, especially in the evaporators area, there is a very high humidity accompanied by significant temperature. The causes are primarily related to massive emissions only in part controlled by the hot steam of pipelines and facilities in operation (fig. 1).

Fig. 1. *Damaged floor due to the presence of water vapour*

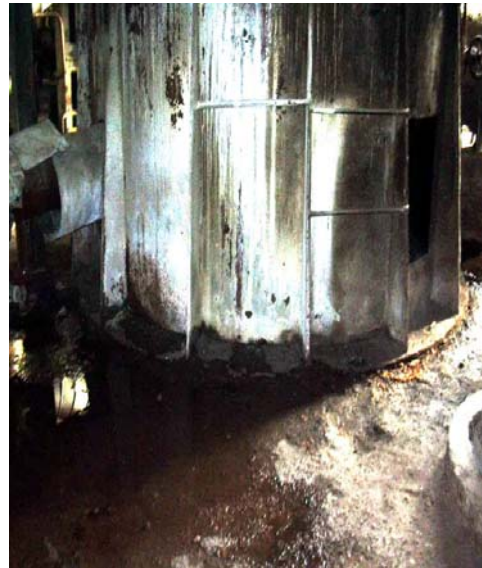
The local damage in various stages of the thermal agent pipeline resulted in massive and uncontrolled leakage of hot water (fig. 2, 3, 8). Over time, this led to significant infiltration of hot water in various areas, and to maintain structural elements completely wet. [4]

Fig. 2. *Persistence of humidity*

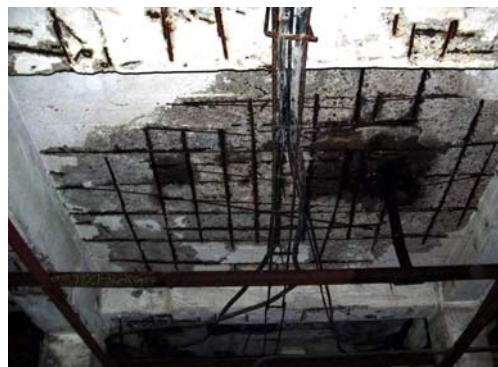
Fig. 3. *Heavily corroded plate*

The reinforcement of the bottom plate will be increased with  $5 \dots 7 \Phi / m$  on the centre of the plate, in each direction, with the equivalent section of the lower half of the reinforcement provided by the project for the area field and anchoring beyond support. Before applying shotcret the visible reinforcement will be protect with an adhesive.

At the bottom of the plate and concrete beams shall apply dry-process shotcrete, after applying a primer layer with an adhesive.

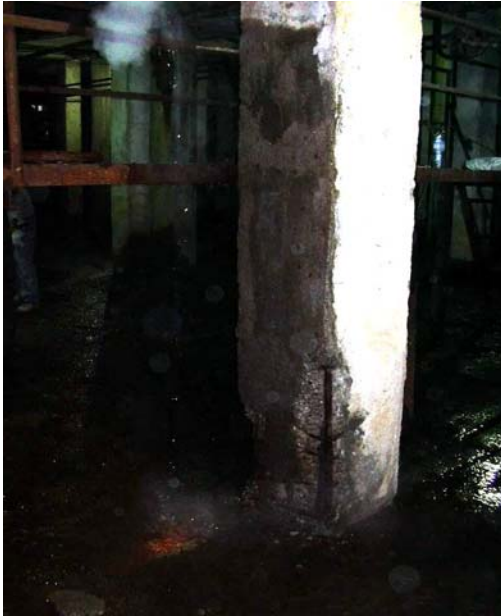
Fig. 4. *Water pooling in the basement*

Under these conditions, the reinforced concrete structural elements obviously investigated shown the advanced damage and deterioration in terms of durability. Damages are illustrated by the attached photos (fig. 4, 5).

To remove aggressive water leakage is necessary to replace or repair installations that lose water and eliminate the existing puddles on the floor.

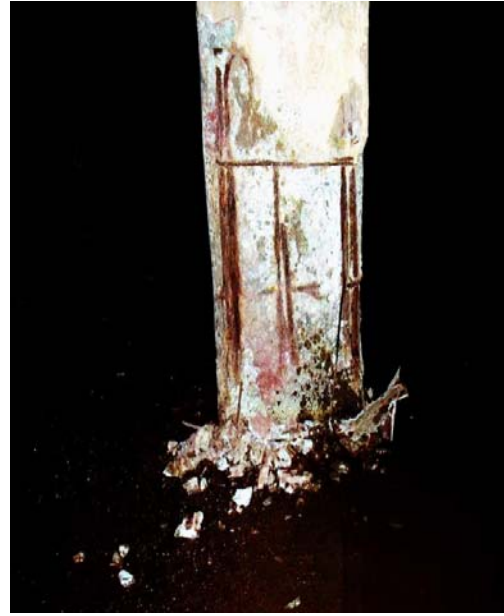
Fig. 5. *The column base strongly corroded due to permanent water from the basement*

Local repairs, mainly at the edges of columns and beams with cover plates shall be made of diameter equal to the diameter affected reinforcement and the application of concrete repair materials with epoxy grout or mortar with adhesive. [2]

Near by the evaporators zone, is necessary to supplement the resilience of columns and beams. Given the limited space for building, capacity to resist is supplemented by up to 40% with a profiled steel structure [3].

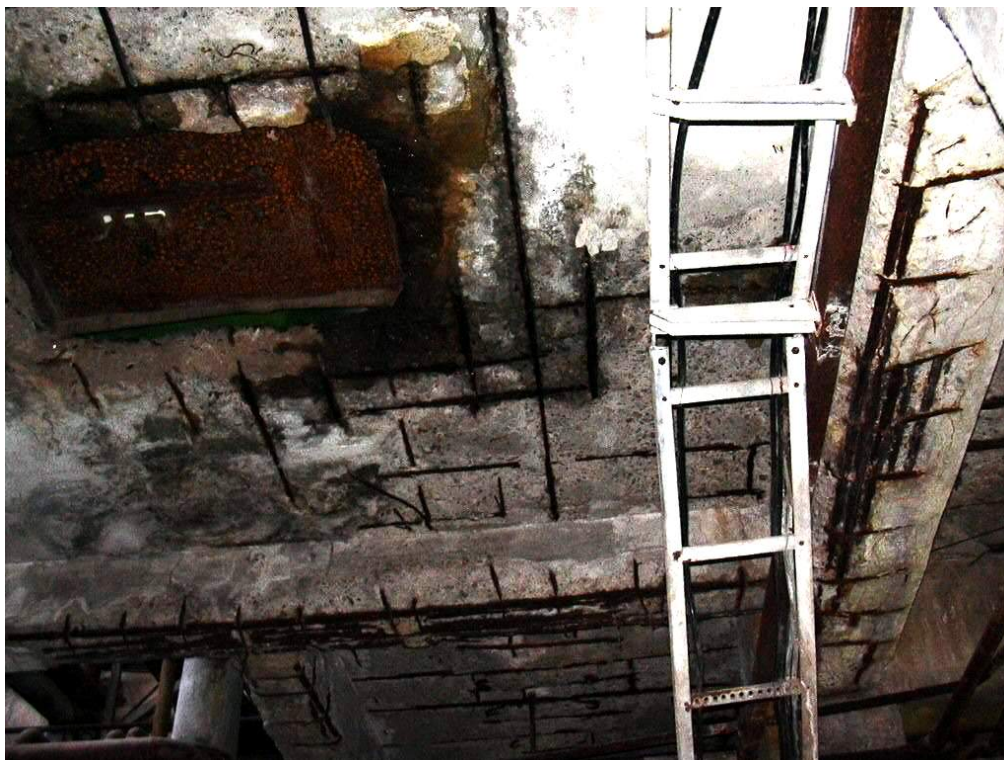
Fig. 6. *Extremely damaged plate*

*near an empty*

They are affected both the strength of concrete and reinforcement in varying degrees, in many cases reaching up to complete destruction elements (fig.1, 6, 7).

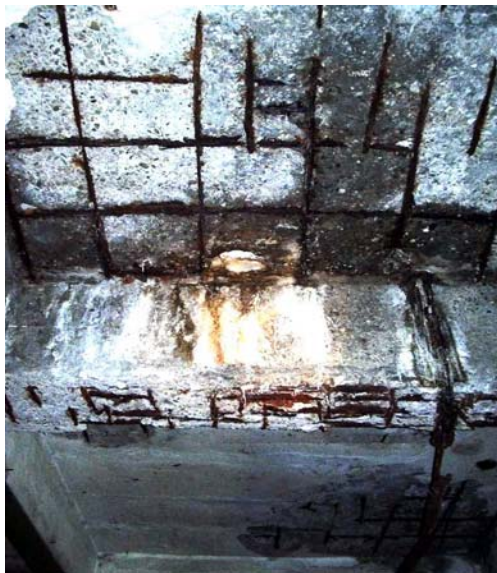
Fig. 7. *Floor with corroded reinforcement*

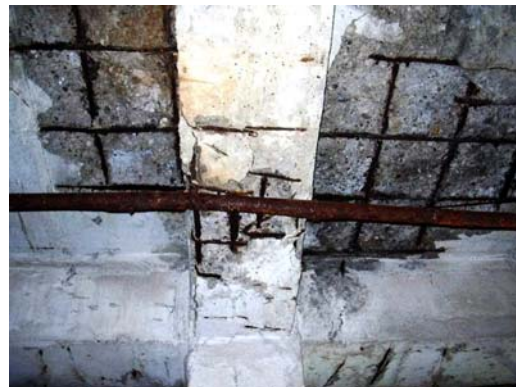
Water samples taken directly from pipes or floor surface established that the aggression mainly at metals and leaching from concrete (fig. 8, 9).

Fig. 8. *Damaged pipe*

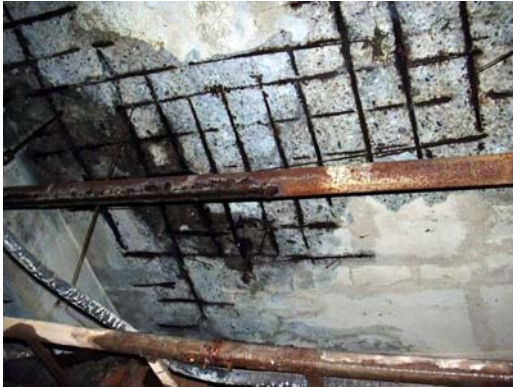
Fig. 9. Damaged pipes
