RESEARCH ON FASTENING SYSTEM DAMAGE TO THE DRUM ON LG WASHING MACHINE

Abstract: This paper presents aspects of the fastening system damage drum LG washing machine model. Research undertaken leads to the idea that the material it is made fastening system of the drum on LG washing machine model is inadequate.

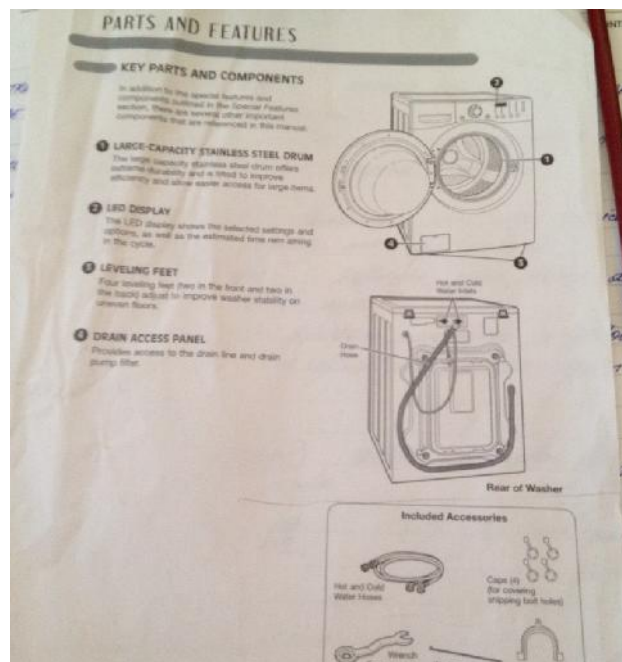
- Hull (1)
- The electric motor (2)
- Drum with shaft motor and fastening system type star with three arms (3)
- The electrical and electronics installation (4)

Figure 1: The main components of LG washing machine

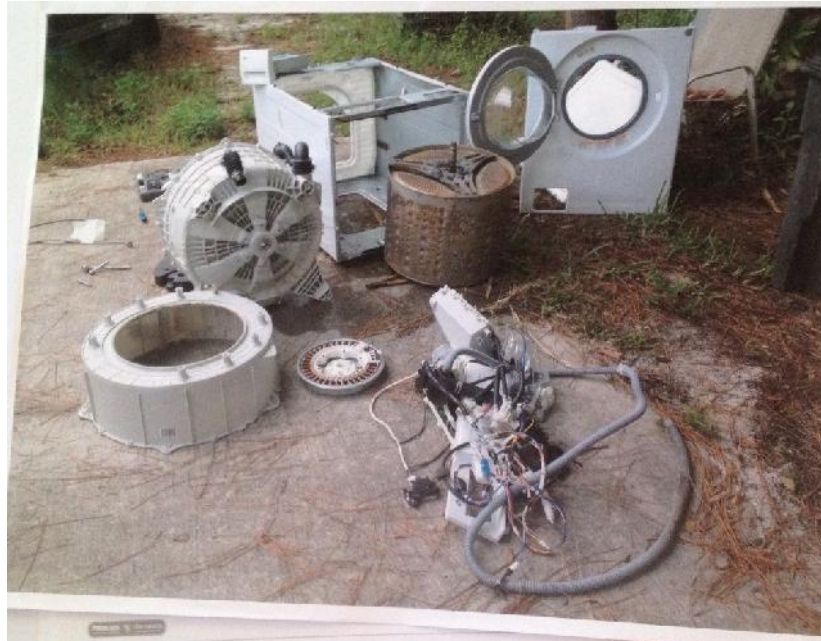
Figure 2: The LG washing machine model disassembled

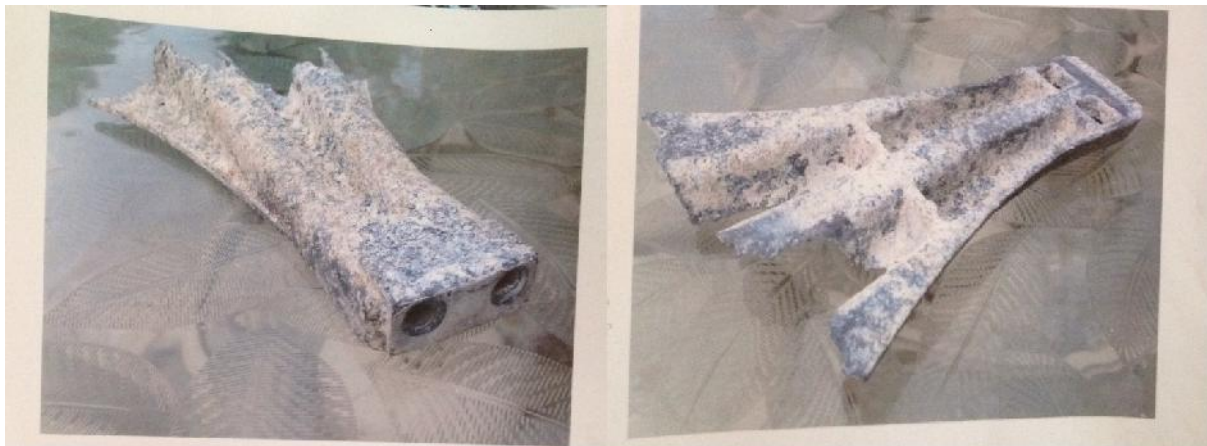
The material used for the star fastening system with three arms secured to the bottom lid of the drum is an aluminum with a very grainy internal structure.

Figure 3: The material used for the star fastening system with three arms

Also, in future papers we will present proposals for the material that its made the fastening system of the rolling drum and technology of its grip.

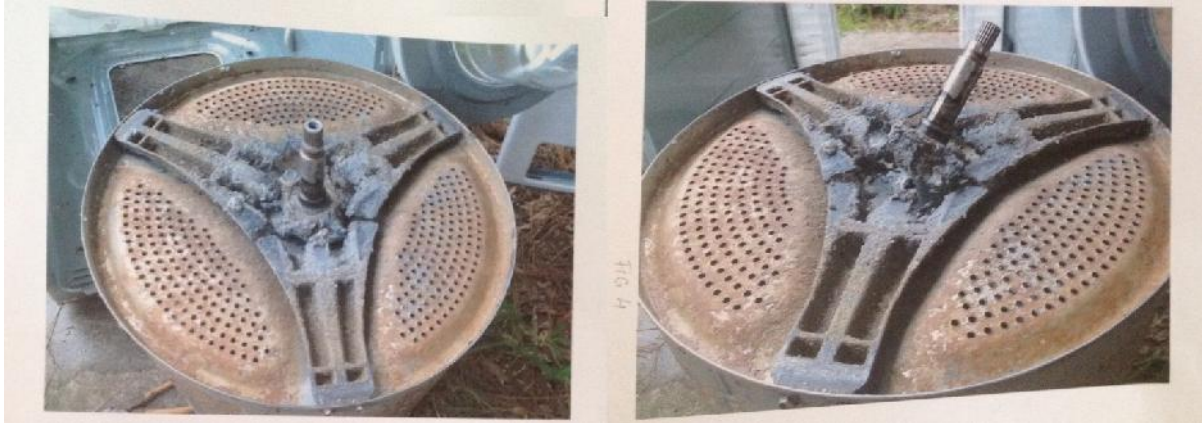
The drum is mounted on the shaft motor using a ball bearing.
Can be observed the detachment of the three arms of the star fastening system of the drum through his bottom lid.

Figure 4: The fastening system of the drum with three branches deteriorated
