# **Analysis of the Car Bodywork Protective Coating's Destruction in Contact with Marine Bird Droppings on the Black Sea Coast**

**Abstract.** In the paper we take in considerations some possibilities of identify, based on a "template or pattern visually determined" the car bodywork protective coating's destruction in contact with marine bird droppings on coast zone - referring directly to a specific panel of a premium body frame manufacturer – where, through experimentally searching reporting referential and systematic precision measurements of coating thickness in the affected area, we shape the deformation of the coating and simulated it in a virtual environment, highlighting possible causes of the loss of the aesthetic qualities protection of the car-body-frame film layer.

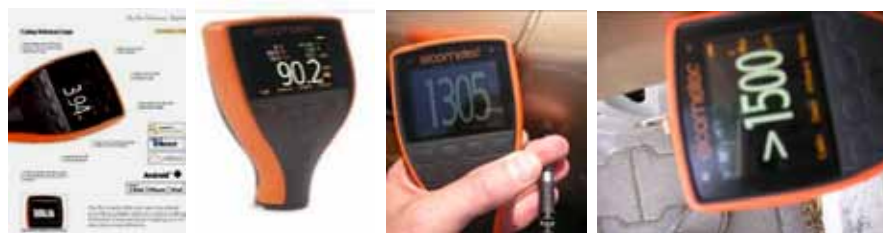
b. Left rear wing of the car in case, viewing on B zone - area under further "zoom" virtual measurements investigation

area (*Figure 1 B-zone*, bounded by the measuring points 9,10,11,18,12,25,13,14,15,16 - corresponding to the measurement values of the coating thickness), to establish a "template or a pattern" deformation, and later, to compare it with the related assumptions and existing cases in the bibliography in order to move forward and argue a possible succession of emergence and evolution of the destruction. (*Figure 3*).

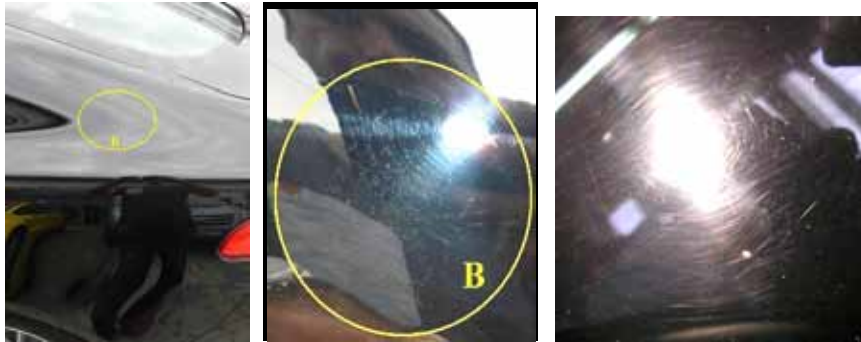
area of interest investigated in the aesthetic destruction signaled was made a strong polishing action with a rotary device, without the removal of the reported deficiency (Figure 2 a, 3).

*a. in relation with paintwork coating damages; Area B-Fig.1*

- polisher in his effort of clearing and uniform the coating damaged surface – fig.2,a,2,3, (evident transparent coating circular destructions –in polarized light);
5. It is likely that once damaged the paint and the varnish, either from technological or from external reasons (*through its removal by an unauthorized intervention*) to be amplified the initial destruction, whereas in the polarized light zone we can clearly observe "circular grooves" resulting from unauthorized polisher or likely improper abrasive grain based on chromium (*Figure 2,a*).

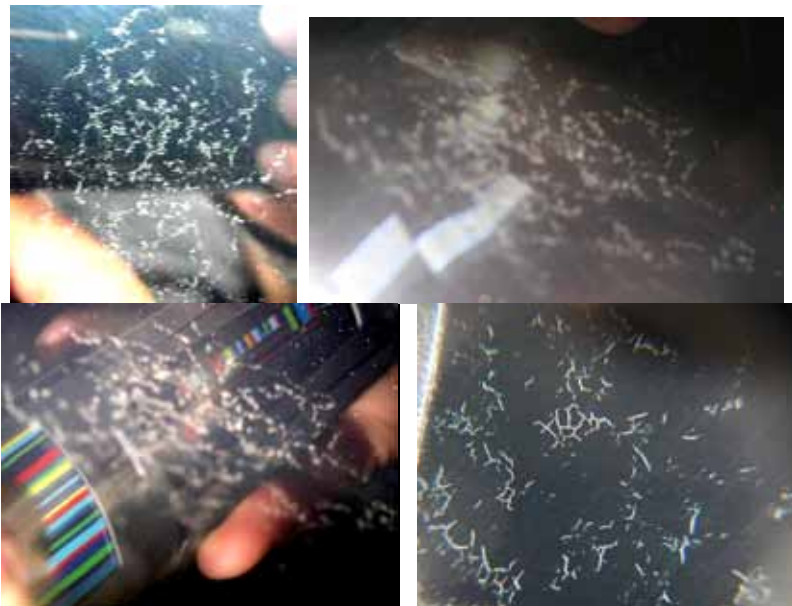
*b. zoom on "spider type template" area B - under investigation*

**Fig. 2.** Photos of the claimed aesthetic damaged area of the *left rear wing* body panel

The related image's documentation available in the bibliography and in other video and photo documents from the Internet (*whose content was selectively presented in Appendix 1*), show that the interaction of bird droppings over the covering film coating of a car body resulting can be compared with a form of destruction or „a pattern - spider web type -" as the the owner of the car in question complained on In the court relating with its left rear wing (*Figure 2 b*) damage. In this stage we can advance the following observations:

1. Architecture (design and organization) claimed the overall destruction of "spider web" on the paintwork with color pigment under the transparent layer of lacquer is similar to those identified as "follow the dung-bird droppings -type" on its own coating layer premium car body frame.
2. We can not compare the magnitude of destruction "in deep" because no producer technical data were provided for comparison in this respect and for the car in the case is considered that the not conform polishing treatment destroy the margins of

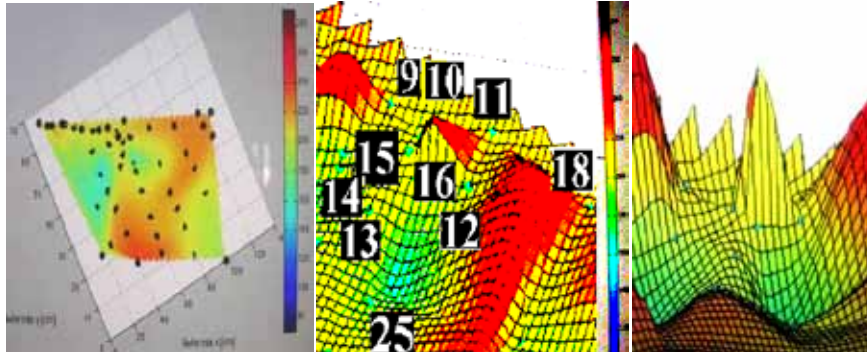
a. car left rear wing –in the case- with B -fig.1 under investigation area (visualization with virtual magnifying "zoom")

Mathematical distribution defined by the measuring points 9,10,11,18,12,25,13,14,15, 16, 25 and experimental results in terms of coating thickness analysis -inside manufacturer limits-

**Fig. 3.** Issues getting through virtual simulation in MatLab of the coating thickness on the frame panel „rear wing” B area

4. Since the relevant experimental data reveal that in the B area from *Figure 1* has been shown to be measurements with uneven horizons of izoheights lower than adjacent areas it is possible that this highlight the damages made by an unauthorized
