SEM STUDY ON FRACTURE BEHAVIOR FOR PA 6 COMPOSITES USED ON AUTOMOTIVE PARTS

A.D. Botezatu*, M.I. Ursu, O.E. Gradin, M.C. Rusu
Department of Materials Engineering, Renault Technologie Roumanie,
*domnica-angelica.botezatu@renault.com

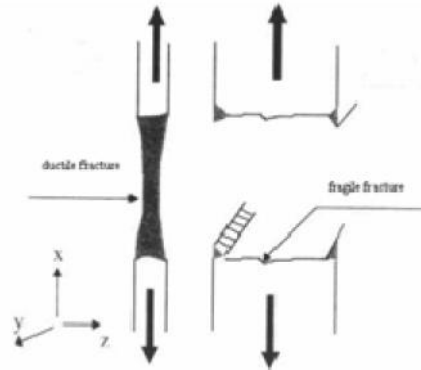
A large number of studies have indicated that plastic deformation of fiber-reinforced polyamides is governed by the nature of fibers, its percentage, size, shape and orientation in the polymer matrix [11,12]. Simultaneously, the fragile or ductile behavior of the fiber reinforced polymer composites is conditioned by the thickness of the material subjected to stress (Figure 1). Thus, a thick material will limit the detachment phenomena due to a high level of shear shrinkage into the constraint area, favoring a fragile fracture of the material.

Figure 1: The influence of material thickness on the fracture behavior

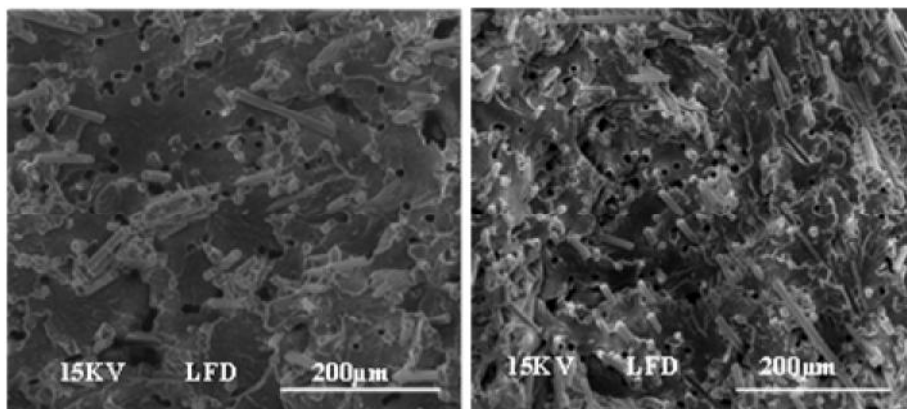
Representative SEM micrographs of the surface from a fractured 30% glass fibers reinforced polyamide 6 composite are presented in Figure 2. Short glass fibers are intimately mixed in the matrix and are distinguishable. The fibers are preferentially aligned in flow direction for injection molded part. Both the micrographs show that most of the glass fibers are pulled out (see the pull out fibers and pull out holes). The fibers surface seems to be smooth and without any presence of residual matrix indicating a poor adhesion between glass fibers and PA 6 matrix, most probably due to the non-treatment of the fibers. Thus, the fracture takes place at the interface matrix – fiber. These characteristics clearly show a brutal fragile fracture for the 30% GF reinforced PA 6 composite.

Figure 2: Scanning electron micrographs of brutal fragile fracture for 30% GF reinforced PA 6

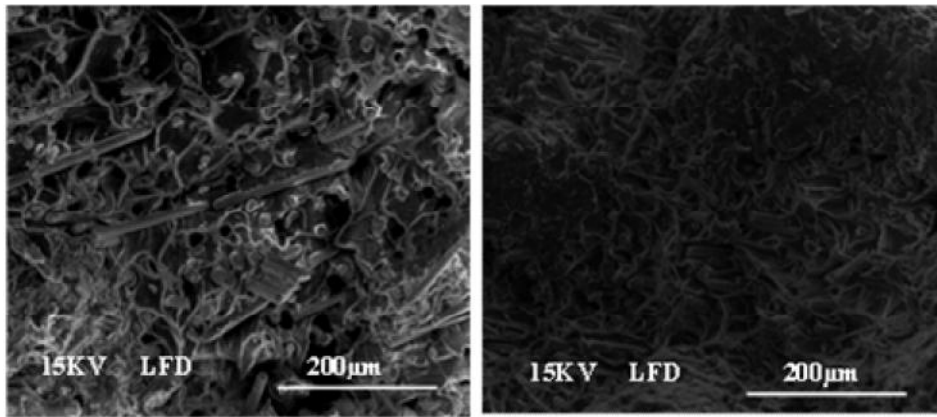
The glass fibers take up greater stress in the composite, reducing the matrix stress, which is too small to promote matrix-governed deformation such as rubber cavitations and matrix shear yielding. In contrast, the micrographs from Figure 3 show ductile fracture behavior further reduced in the ligament region of the matrix. Some plastic deformation can be observed in the matrix ligaments. This kind of fracture behavior mostly appears in the propagating area of the crack. After a ductile behavior presented in the propagating area, the crack is propagated into the rest of the polymer matrix following a brutal fragile behavior.

Figure 3: Scanning electron micrographs of ductile fracture for 30% GF reinforced PA 6

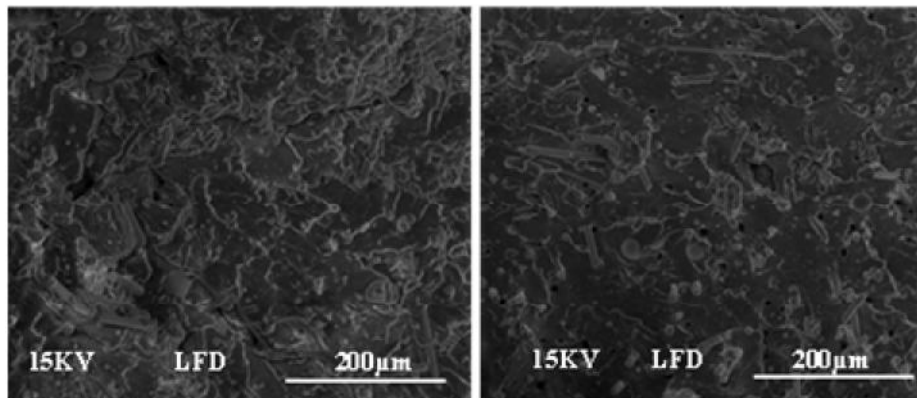
Figure 4 represents scanning electron micrographs of a fracture behavior of 20% glass spheres and 10% glass fibers reinforced polyamide 6 composite. Analysis of these cracked surfaces puts in evidence a fragile fracture behavior, poorly revealed on this type of material. Glass fibers and glass spheres are mixed in the matrix and are clearly distinguishable. The fracture behavior is accompanied with noticeable de-bonding between the matrix and the reinforcing fibers. However, the adhesion between glass spheres and PA 6 matrix appears to be stronger. This observation is indicative of a strong interface with good stress transfer from the polymer matrix to the glass spheres, due to a higher contact between the glass spheres and the PA 6 matrix.

Figure 4: Scanning electron micrographs of a fragile fracture for 20% GS – 10% GF reinforced PA 6

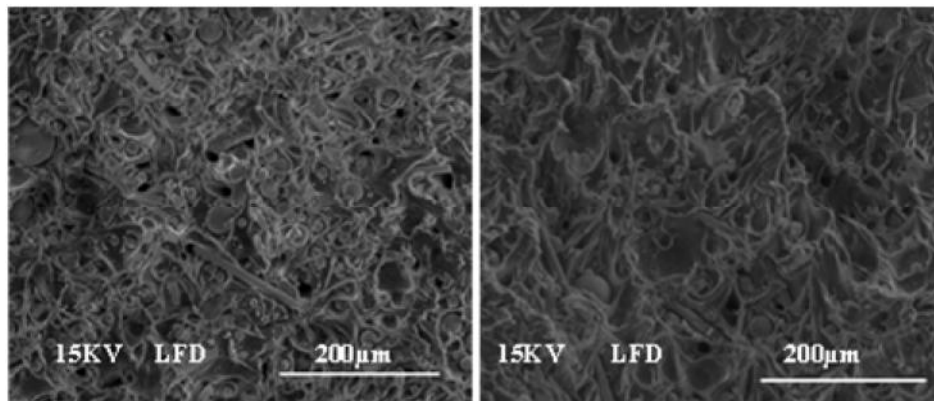
Figure 5 presents a ductile fracture for the 20% glass spheres and 10% glass fibers reinforced polyamide 6 composite. Ductile fracture is preferred in most applications and is characterized by an extensive plastic deformation ahead of crack (necking). In these cases, the crack resists further extension unless applied stress is increased. The ductile behavior of fracture is accompanied by slow propagation and important energy absorption before fracture.

Figure 5: Scanning electron micrographs of a ductile fracture for 20% GS – 10% GF reinforced PA 6
