The 4th International Conference  
"Advanced Composite Materials Engineering"  
COMAT 2012  
18- 20 October 2012, Brasov, Romania

## COATING PROPERTIES OBTAINED BY THERMAL DEPOSITION USED IN CAMS/CAMS FOLLOWERS APPLICATIONS

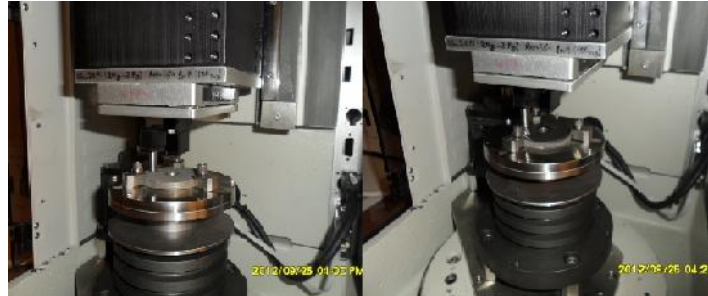
**Figure 1:** The way how the sampled is mounted on the CETR UMT-2 tribometre:  
a) the samples subjected to friction wear without lubrication;  
b) the samples subjected to friction wear lubrication.

The two samples were mounted on the device shown in Figure 1. The tests were performed in dry and in lubricated conditions with SAE 5W-30 Audi Original oil, with a viscosity of  $51.7 \text{ mm}^2/\text{s}$  at  $40^\circ\text{C}$  in according to the ASTM D-445 standard.

The experimental tests were performed with CETR UMT-2 tribometer with a pin-disc test system [1]. We used a pin with a diameter of 6,3 mm and a disc sprayed with 40Cr130. At a radius of 10 mm from the center of the disc a normal pressures forces with a value  $F_z = 10 \text{ N}$  was applied through the pin, for a period of 10 minutes. Tests were performed both under dry friction wear and lubrication conditions.

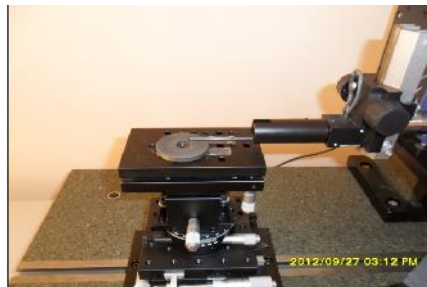
**Figure 2:** The mounting of the sample on the stand to determine the roughness of the profile

Since the deposited layer surface roughness is very important, it was measured before and after the abrasion test to estimate all the wear resulting from friction [2]. In Figure 2 is presented the mounting of the sample in order to determine the roughness of the layer.

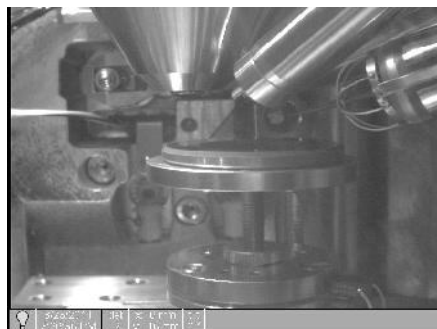
**Figure 3:** The mounting of the sample in the working room of the microscope

In Figure 3 is presented the mounting of the sample in the working room of the microscope [3].

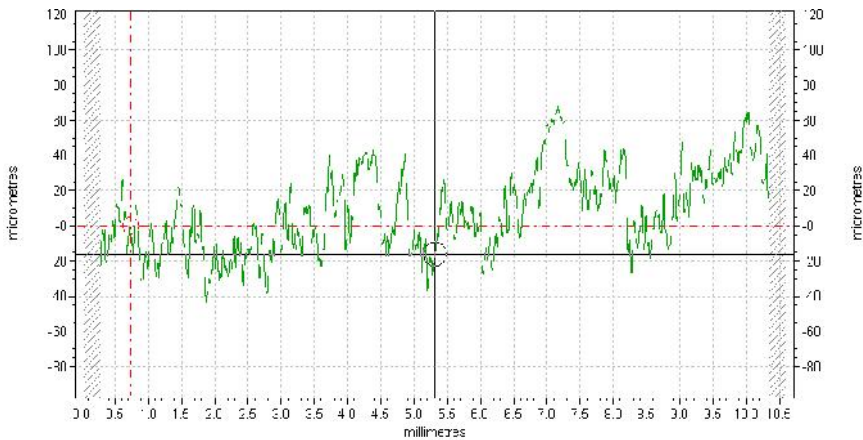
Figure 7 presents the scanned tested sample after the dry friction test. A wear depth of 80  $\mu\text{m}$  can be observed in the picture.

The shape of the channel due to wear is achieved with the Login Form Talysurf 50 profilometer, produced by Taylor Hobson, England.

**Figure 7:** The shape of the wear trace under dry friction condition

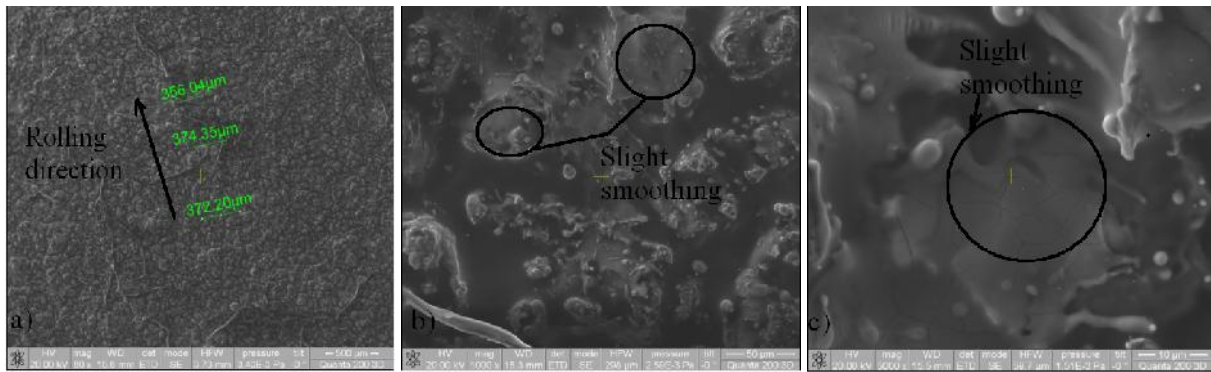
In Figure 9-a is observed that the width of the wear track is between 336  $\mu\text{m}$  - 374  $\mu\text{m}$ , but on the surface of the layer, shown in Figure 9-b, a smoothing appears. In Figure 9-c it can be seen that the layer has compacted as a result of the wear test. There are no traces of pitting on the layer [6].

**Figure 9:** The appearance and dimension of the wear trace resulted after lubricated friction test:  
a) 80X, b) 1000X si c) 5000X
