EXPERIMENTAL STUDY OF THE VEHICLE-PEDESTRIAN COLLISIONS

ABSTRACT - The paper describes the way a vehicle-pedestrian collision process takes place, aiming to a better understanding of the phenomena that appear within the dynamic of this kind of road events.

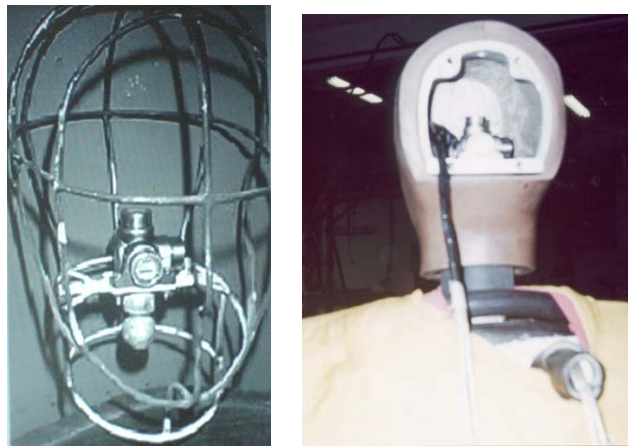
According to the description in [3,4] the pedestrian dummy was 73 kg weight and 180 cm height and was conceived to have 11 body segments, which corresponds to the anthropometry of a 50th percentile male adult [2]. The dummy has been modified in the Passive Security Laboratory Pitesti by adjusting a Hybrid II dummy head to it, equipped with an accelerometer, mounted in its center of gravity. In order to better fasten the dummy's head, modifications were made to bind it in three points, on the shoulders and spine respectively. A second similar accelerometer was mounted on the spine of the dummy, in order to measure the acceleration at thorax level. The accelerometers were mounted with their axes parallel to the three anatomical planes of the body

Figure 1. Accelerometer, mounted in head's CG (left). Dummy's head (right)

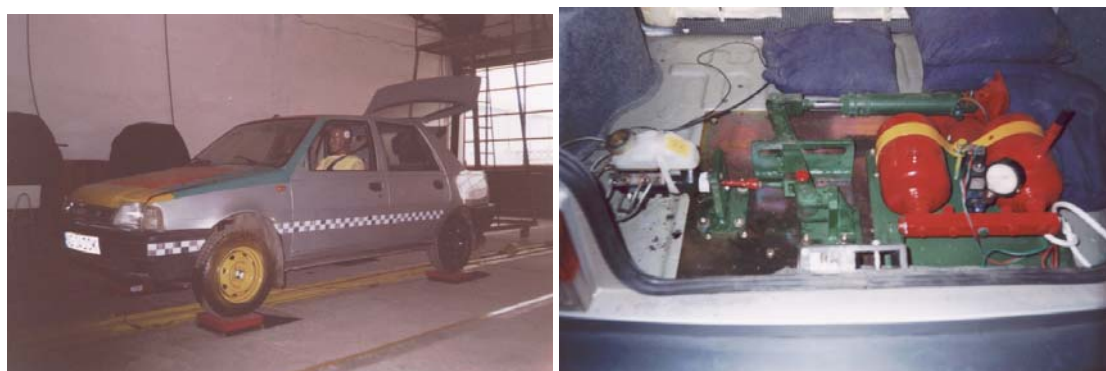
The vehicle was prepared for collision and equipped with two humanoid dummies Hybrid II. The braking system was mounted in the hood. The test vehicle was a Dacia Nova, with a weight of 1024 Kg and its fuel tank empty. The frontal area and the hood were painted to differentiate the zones with different pedestrian harming potential, and to facilitate the software image analysis.

*Figure 2. Weighing the test vehicle equipped with two humanoid dummies Hybrid II. (left)
Braking system mounted on vehicle (right)*

A special electric cable triggered breaking system was mounted in the trunk of the car. Its purpose is to trigger the break on the vehicle at the moment of impact with the pedestrian dummy, and avoid destroying it by impact with the fixed collision barrier (170 tons + mechanic – welded block for delayed collision) situated at approx. 15 meters from the impact area.

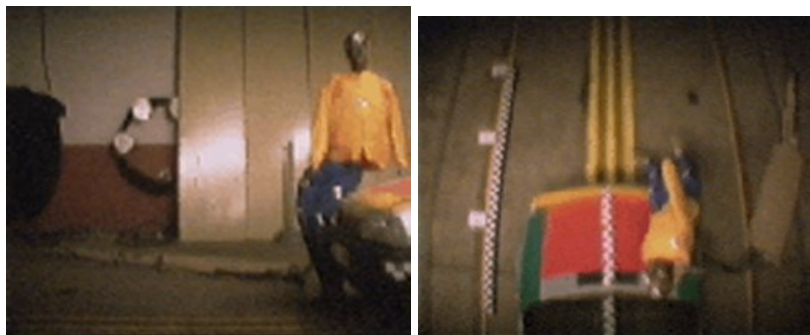
This stage is comprised of a series of sub-stages due to the complexity of the phenomena that occur: initial impact with the hitting of the pedestrian at the knee level; leaning the pedestrian's femur against the hood edge, simultaneously with the swinging of the upper side of the body on the vehicle's hood; rotating the pedestrian's body around his longitudinal axis; impact of the pedestrian's head with the hood; falling off the vehicle. At the initial impact the pedestrian is hit at the knee level by the vehicle's bumper. Since in the case presented the motor vehicle was braked only with the rear axle there was not notice the pitching movement while braking. Briefly after, the hood's edge comes into contact with the pedestrian's femur.

Figure 3. First test (left). Pedestrian's swinging on the hood (right)

Here we can see the „molding” phenomena of the lower limbs on the frontal area of the motor vehicle. This is due to the mobility of the joints of the lower limbs or, in the worse cases, due to the breaking of the bones. The lower area of the leg, up to the knee, tends to be pulled under the vehicle but due to the difference of weight, between this region and the rest of the body, at the end the „molding” phenomena occur. During the stage where the legs are pulled under the vehicle, ankle fractures can occur. The pedestrian’s swinging on the hood is delayed as compared to the impact moment.

During the first test, the pedestrian was set in front of the motor vehicle in a sidewise position (crossing the street), with the left leg toward the vehicle. The impact took place in the left knee area, slightly above it. Impact speed of the vehicle was 29.58 km/h and the pedestrian was hit by the vehicle's mid bumper. The brake system was engaged just 2 m before the collision took place.

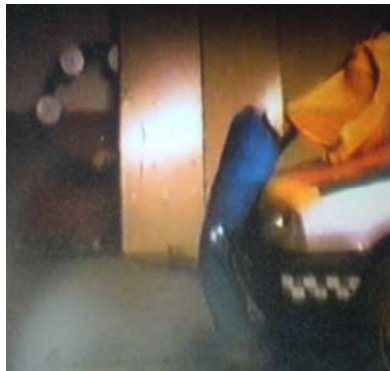
The pedestrian’s rotation movement around its longitudinal axis arises as a consequence to the position of the dummy’s leg that is first hit by the bumper. The rotation is delayed due to the mass distribution on the pedestrian’s legs.

Figure 4. Second test

During the second test, the pedestrian, placed facing the motor vehicle, was hit head-on by the mid bumper of the vehicle that was moving at a constant speed of 30.21 km/h. The pedestrian was hit in the knee area during the impact. After the tests were conducted, in order to obtain the digital format diagrams of head and thorax acceleration and speed values , the results obtained on oscillograf's paper, were scanned in „Black and White Drawing” format and saved as files in „Windows Bitmap Monochrome” format.

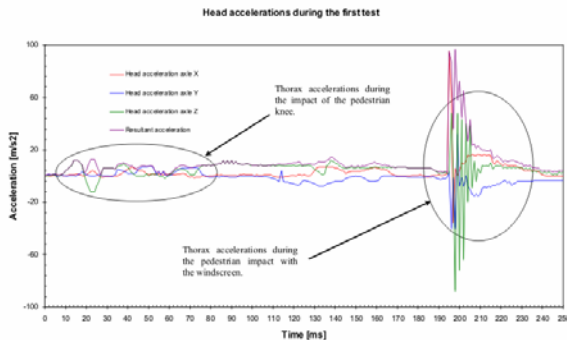
Figure 5. Head accelerations during the first test

By analyzing the obtained diagrams it can be stated the effective contact between the pedestrian dummy and the motor vehicle lasts for approx. 250 ms, at an impact speed of 30 km/h, after which the pedestrian falls down to the ground. The impact in the area of the pedestrian's lower limbs lasts about 90 ms after approx. 190 ms the pedestrian's head hit the windscreen. In both variants of tests the pedestrian's head was projected into the vehicle's windscreen. Also the lower limbs were broken in the contact area with the bumper. During the second test the dummy broke at the pelvis joint. This was due to the joint torque adjustment, the torque exceeding the breaking point of the joint in the welding spot. The average acceleration values recorded, from the moment of the impact in the knee area, up to the impact of the pedestrian's head with the windscreen, and during the secondary impact with the ground are as follows:

From the recordings, the acceleration diagrams and the filming done, we come to the following: the maximum impact force between the vehicle’s bumper and the pedestrian occurs after approx. 25ms, the result being the breaking of the dummy’s leg; the value of the force at the knee level in this case was about 10000 N; the maximum acceleration was

recorded at the time of the collision between the head of the dummy and the vehicle's windscreen, 190 ms after the initial impact; the value of the acceleration at the level of the head in this case exceeded 100 g; at thorax level the average acceleration value recorded over a period of 20 ms was approx. 18g and took place at the secondary impact with the ground; the projection distance of the pedestrian in the case of the first test was 7.5 m on the same direction with the vehicle motion; the damage inflicted upon the motor vehicle during the collision with the pedestrian consisted of slight impact traces in the upper part of the hood and the breaking of the windscreen; even though during the first test the pedestrian was hit with the center of the bumper, due to the swinging motion imprinted, the dummy fell off the right side of the motor vehicle, this being confirmed by the traces on the hood.

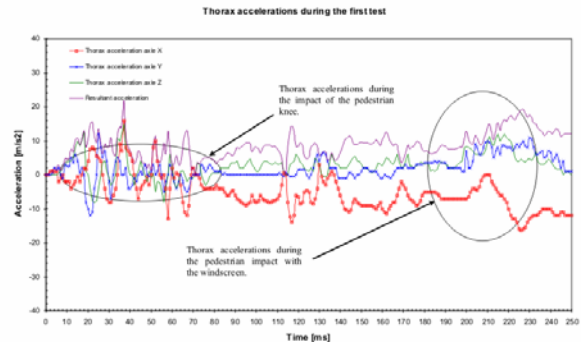
Figure 6. Thorax accelerations during the first test

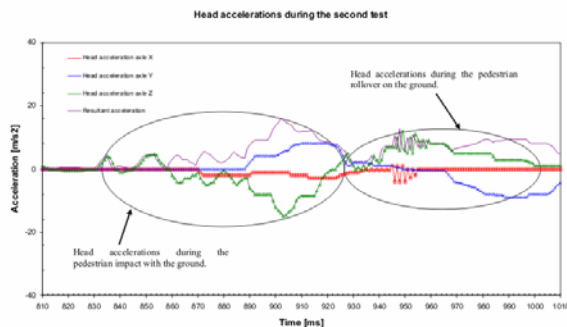
Figure 7. Head accelerations during the second test

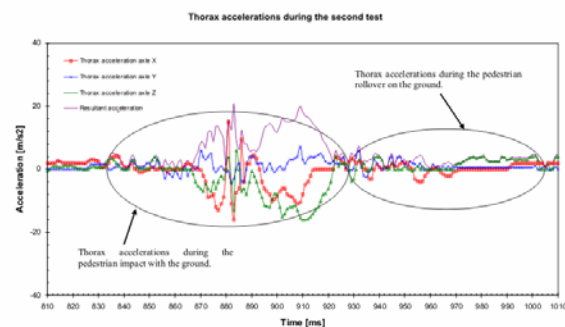
Figure 8. Thorax accelerations during the second test
