INVESTIGATION OF PRECAST CONCRETE ELEMENTS IN TERMS OF DURABILITY

Abstract: *This study refers to several prefabricated reinforced concrete, components derived from decommissioning of industrial buildings owned by the company PREFEA SA Brasov. The study looked at various issues that may affect or influence the durability of precast under normal conditions of use.*

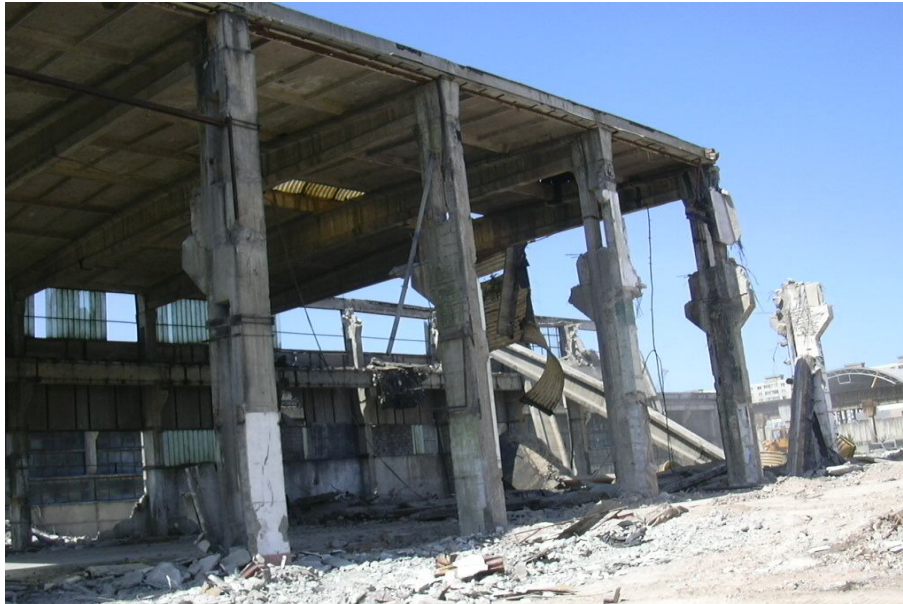
Fig. 1. *Image of time shots demolishing from the prefabricated workshop.*

belonging the prefabricated production workshop (fig. 1), hall was installed during 1950 - 1952 (62 years) like columns, prestressed beams and caissons and other elements belonging the roof workshop of

reinforcement (fig. 2), hall built between 1952 and 1953 (60 years) like prestressed trusses and skylights. In fig. 1 can be seen the conditions are very good for the prestressed beams and connection of it with the column. Reinforcements from the prestressed beams are in very good condition, without rust (fig. 3).

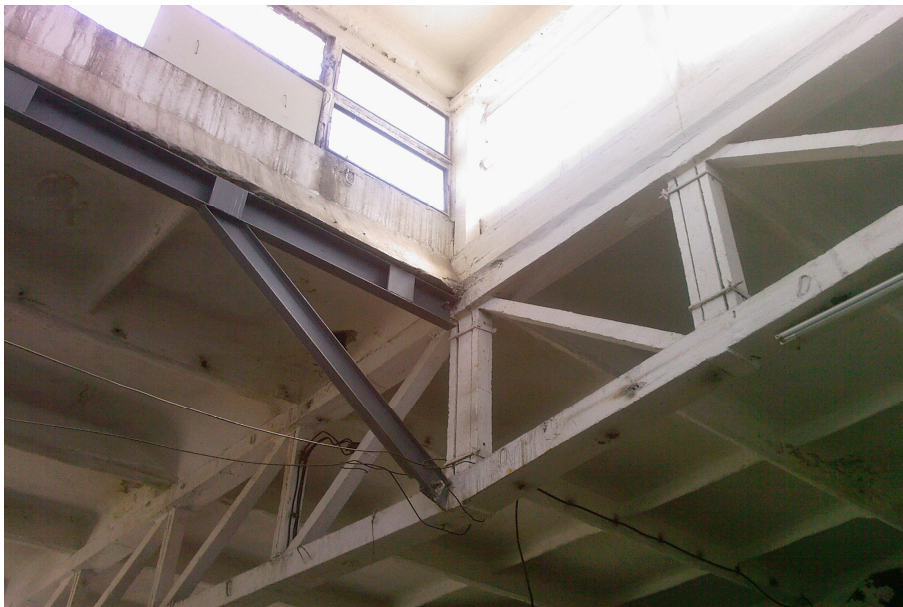
Fig. 2. *Image before demolishing from the reinforcement workshop*

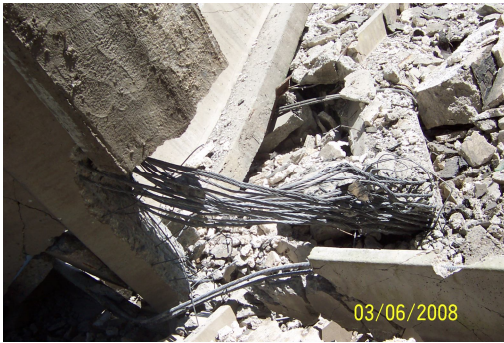
Fig. 3. *Reinforcement of prestressed beams*

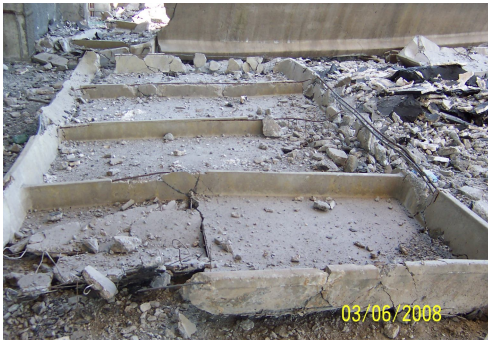
In fig. 4 we can see good state of caissons with low corroded reinforcement at the bottom of plates.

Fig. 4. *Surface element type ECP*

Were consisted a few shortfalls as example: the reinforcement of resistance is smooth, therefore without an adhesion of or proper cooperation, insufficient coverage at the bottom reinforcement with concretes at caissons, non-satisfying the blocking thorons protection.

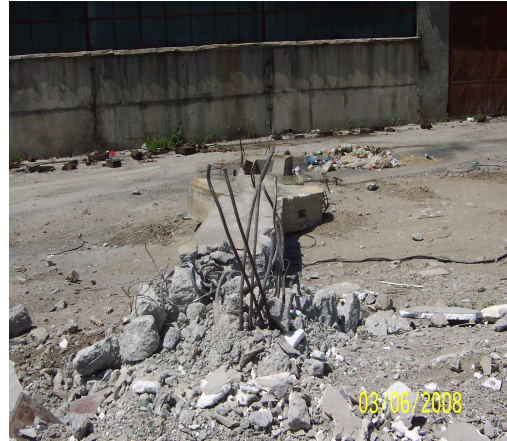
In fig. 5 is observed a reinforcement column in very good condition, without rust. At the workshop roof of reinforcement can be observed prefabricated caissons and truss reinforced concrete both in a very good condition of conservation (Fig. 6).

Fig. 5. *Column type peron*

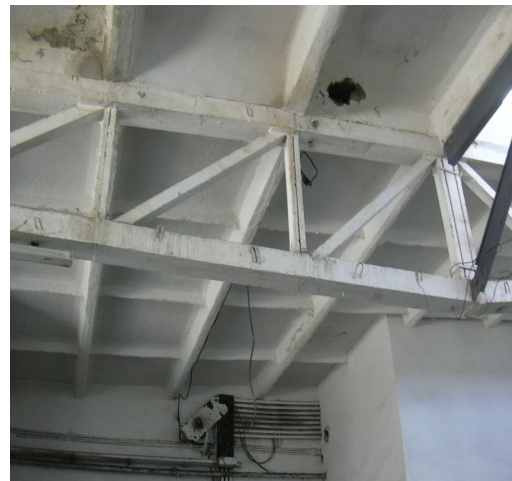
Fig. 6. *The roof of workshop of reinforcement*

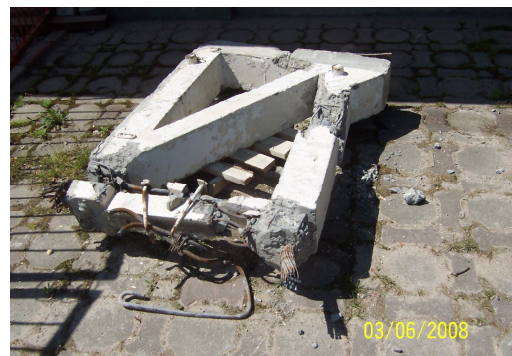
In fig. 7 is observed strands from soles truss as well non prestressed reinforcement are in a state without degradation.

Fig. 7. *Stranded wire from soles truss*

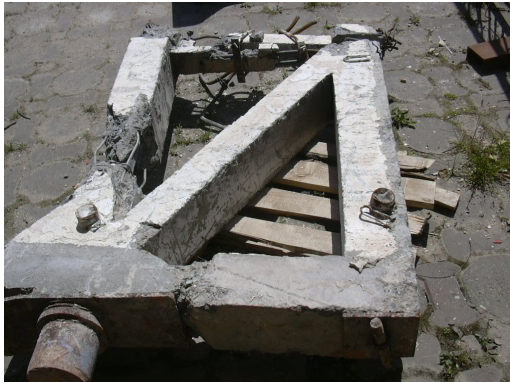
Blockage strands have only one started rusting generally having good time behaviour (fig. 8).

Fig. 8. Reinforcement blockage for prestressing

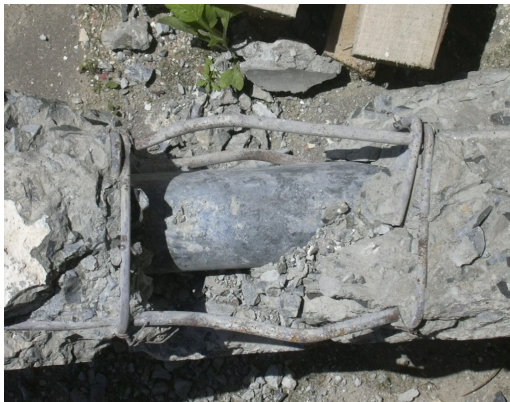
The sheath for strands did not show any degradation as can be seen from fig. 9.

Fig. 9. Reinforcement sheath

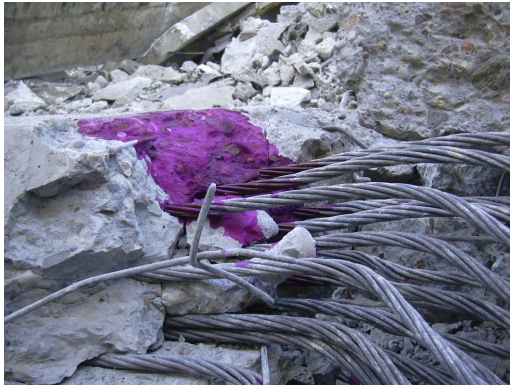
Concrete carbonation is determined by sprinkling with 1% phenolphthalein solution concentration on fresh broke. Phenolphthalein have turning range of the colour from colourless (pH = 8.3) to red violet (pH = 10.5). Alkalinity is characterized by a high pH, so in areas where concrete has not lost the alkalinity, that no carbonation, it will be intensely coloured after sprinkling with phenolphthalein.

All items tested with alcoholic solution of phenolphthalein were stained red violet (fig. 10).

Fig. 10. *Alkaline concrete in all beam section*
