Study of some Tribological Aspects of the Charging System of an IC Engine

Abstract. The objectives of this paper were focused on the study of wear of the turbocharger, and providing a solution to ascertain friction losses in this equipment, because the value of this parameter contributes to pollutant emissions level of the engine.

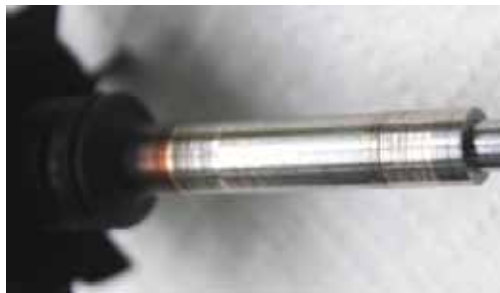
Fig. 1. Turbocharger shaft scoring

Asperities of uneven surfaces during high rotational speeds of the shaft are welded and break, producing a metal transfer from one surface to another. As seen in figure 1 and figure 2, scoring can completely destroy the friction surfaces, leading to extreme clearances between shaft and bearing, thus leading to turbine or compressor wheel damage, as shown in figure 2 [4,5].

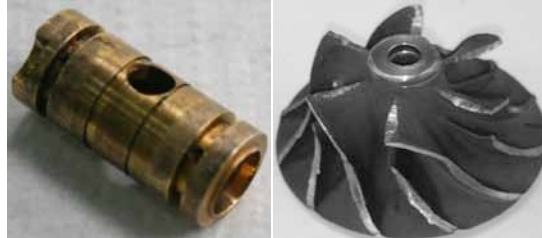
Fig. 2. Compressor wheel damage due to extreme journal-shaft clearance

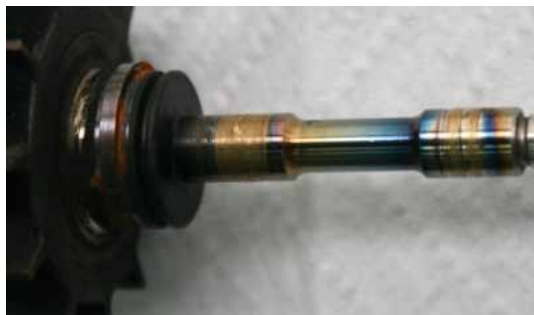
Fig. 3. Turbocharger shaft seizure

Seizure is the result of solid particles in the lubricant or solid deposits on one of the friction surfaces as the result of extreme turbine housing temperatures.

Welding of surface roughness occurs on large areas, blocking the relative movement of the components.

The abrasive micro particles reaching the lubricant layer between the journal bearing and the shaft have a high hardness and a greater diameter than the thickness of the lubricant layer. These hard particles will be embedded in the soft surface of the bearing, and will act on the shaft as a cutting tool. The result will be the fast bearing and shaft clearance change, loss of pressure in the lubricant layer and finally seizure [4],[6].
