# Analysis of the Mid Day Temperature of the Sun Expose Side of the Car Bodywork Protective Coating in Relation with the Contact Destructions with Marine Bird Droppings on the Black Sea Coast

**Abstract.** In the paper we take in considerations the mid-day temperatures that a body car can get in summer, depending of color and type and try to settle its relation with the car bodywork protective coating’s destruction in contact with marine bird droppings on the Romanian Black Sea Coast zone, highlighting possible causes of the loss of the aesthetic qualities protection of the car-body-frame film layer.

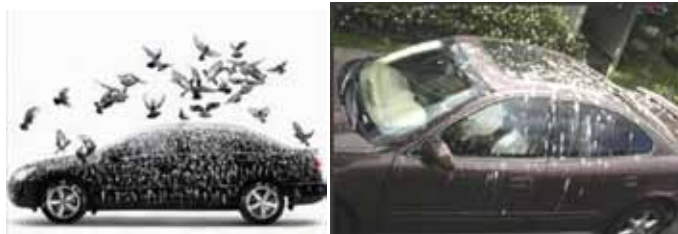
**Fig. 1.** Bird droppings - a nightmare of manufacturers and owners of the modern cars

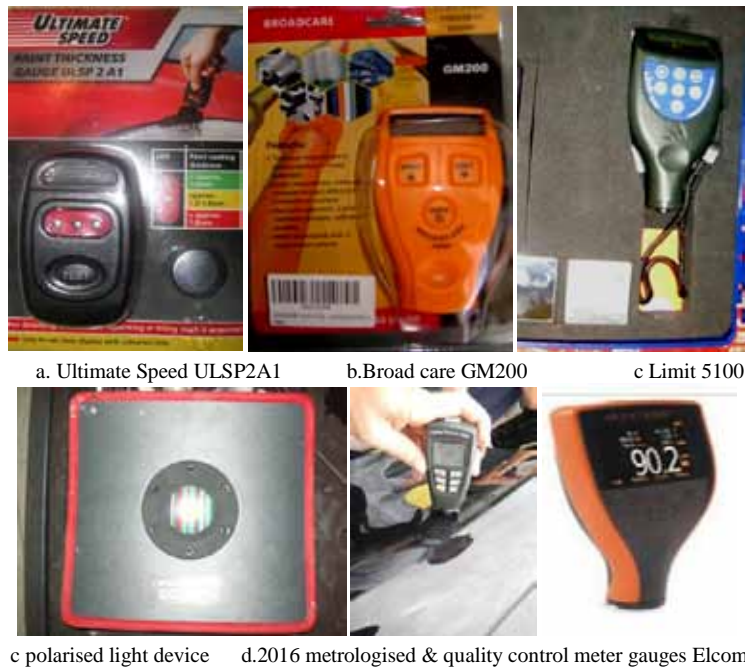
**Fig. 2.** Technical aspects of obtaining experimental measurements of coating thickness used during car coating film thickness distribution measurements on the framepanel „rear wing” - zone B

The multiple analysis carried out on the state of the black body coverage (with multiple layers which include color pigment layer - and final transparent protective layer) (Figure 2, 3) shows that in the area of interest investigated in the aesthetic destruction signaled \*B zone (rear left panel) made by the destruction reaction with marine bird droppings on the Black Sea Coast - in case, were a lot of other complementary acceleration factors that influenced the damage. For example, was made a strong polishing action with a rotary device (Figure 3). Taking a set of measurements *in the area of interest* with properly equipments (fig. 2) it was obvious that the paint had thinner coatings layers due from the shape of the body in the destruction area.

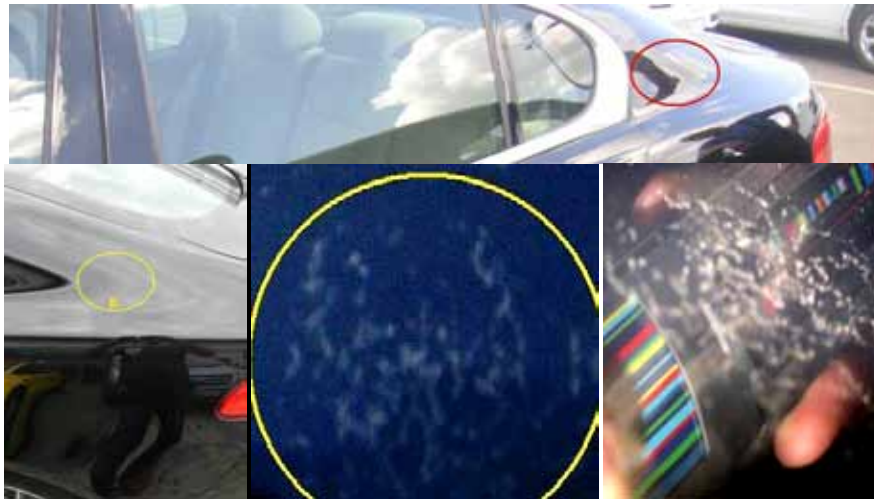
a. B Area                      b. paintwork coating damages lok like the "spider-net" type template

**Fig. 3.** Photos of the claimed aesthetic damaged area B of the *left rear wing* body

Also, after a statistical and mathematical experimental data processing we can see in the deep of the coat structure that there were two types of mechanical stress over the coating framework that interested: on the “up/back part of the left rear panel” we find a depression beneath the bird etching that shows us that during the summer day when the clear coat was expanded the bird droppings that’s dried quickly, became the toughest element of stability of the center of the destruction zone. The colored pigment layer, that expanded not so rapidly as the clear coat, was forced, during the rapid

cooling of the car-panel during the night to crack its substrates and to form a specifically "spider net pattern" under the clear coat (fig.2).

So, in the destruction area we gathered information about the lower thickness (within the limits stated by the manufacturer) of the coat (probably part because of technology coverage on the painting manufacturer's plant, either possible, in our opinion, due to the emergence unauthorized effort applied on the protective surface by strong polishing -hoping uniform the final transparent coating film surface at the site - (fig. 2 - obvious circular destructions show in polarized light), and also of the existing "spider net template or a pattern" deformation under the clear coat (figure 3).

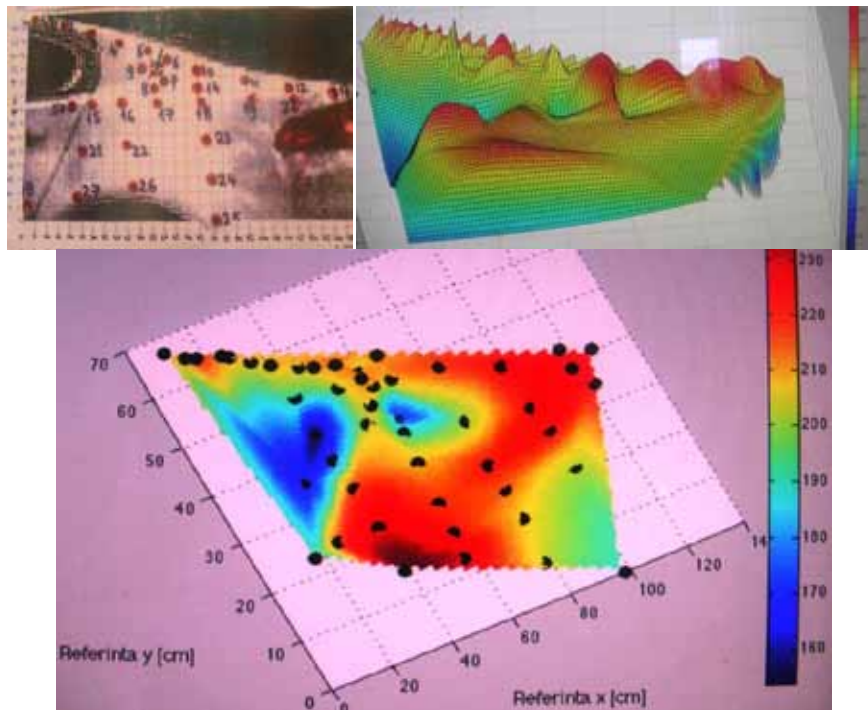
**Fig. 4.** Determination of the real and virtual car body coat thickness surface

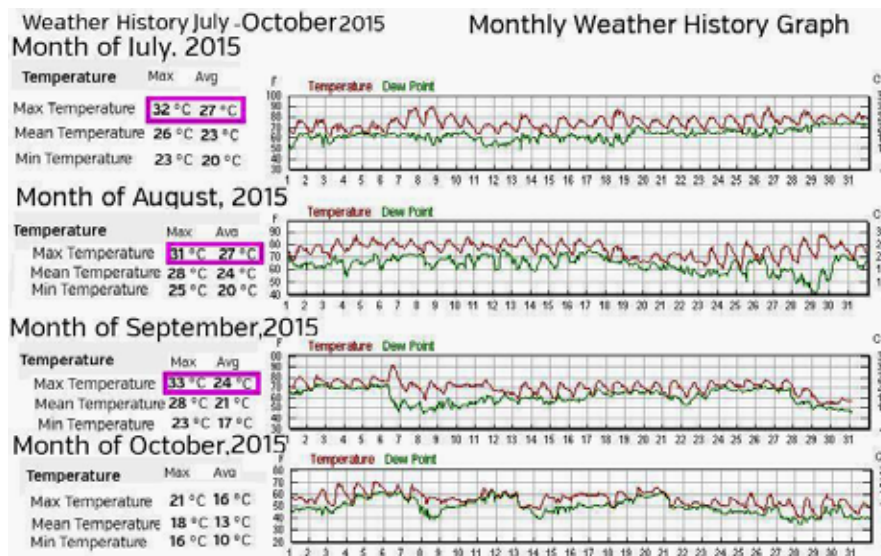
**Fig. 5.** Caloric radiation intensity analysis depending on the evolution of atmospheric temperature in Black Sea Coast Area from July to September 2015

Summarizing the observations, emerge the following assumptions validated by the experimental measurements: 1. The damage appeared likely in the summer time season of 2015, when there were above normal maximum elevated temperatures during the day on the Constanta Black Sea Coast (33-35 degrees C), and when the black color body exposed to direct sunlight reached very high temperature values (60-80 degrees C) due to strong caloric radiation absorbing [6]. Given that on the Black Sea Coast there are many species of marine birds that usually random defecates we started also the search in this direction, linking it with the related observations of specialists in marine biology that shows that marine bird droppings (which varies depending on the species, diet, season) are a cocktail composed of salts rich in nitrogen (8-16%), ammonia, ammonium oxalate, urate, uric phosphate, uric acid and phosphoric potassium (2-3%) / ammonium biological materials, including bacteria and enzymes and that the oil contained in the excrement of seabirds make their adhesion to automotive paint to be big and have the effect of catalyzing attack reactions on cover frame body coating films, we tried to concentrate the specific search on the temperature activator.

We want to see experimentally if, as it says, the dark black non metalized colors of car bodies are most exposed (black amassing maximum heat radiation) and high temperatures during hot summer days amplifies the destruction process (see Figure 5); First we study the weather history of summer 2015 temperatures which reveals medium day temperatures of 25°C-27°C (as it shown in figure.4) assuming that high temperature variation on hot summer days versus night, with daytime maximum temperatures exceeding 30 degrees C and 16-23 degrees C during night time, cause dilation and extent of the clear coat and the paint during the day, and in the event of a deposit which rapidly solidifies contraction of different paint around the varnish and with specific destructions of the paintwork with color pigment. If the reaction persists then cause irreversible damage to the protective layer of varnish and repainting it is necessary on the entirely body part.

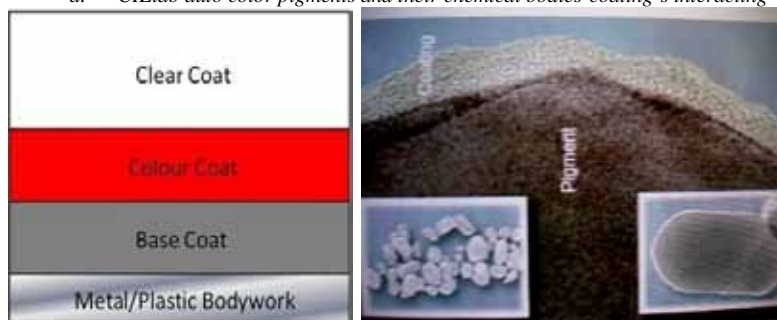
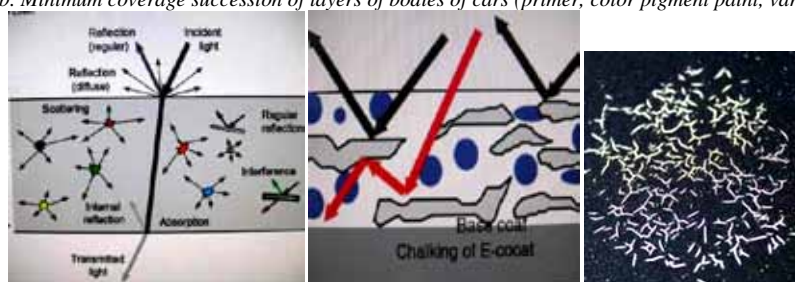
a. CIElab auto color pigments and their chemical bodies-coating's interacting

b. Minimum coverage succession of layers of bodies of cars (primer, color pigment paint, varnish)

c. optical phenomena of color coating's perception

c.1. -with normal arrangement of coating c.2,3 distortion arrangement - . damaged coating layers by external factors such as bird droppings

Fig. 6. Technical and theoretical aspects on „in-time” experimental behavior simulation of body-car-coating (Source: [5])

The results revealed that black panels of the body frame heat up to 74 - 75 degrees C (on the side of the sun) compare with white color that assumes 25-27 degrees C or light metalized grey that assumes 35-39 degrees C. If we compared the exposed part of the body to the sun with the non direct exposed we find differences of 22 to 23 Celsius degrees –for case in study see also Figure 5, case e; for a light metalized brown car body. Different types of spark metallic inclusions in the coat offers different reflection to the sun rays (fig.5) that is why the experiments reveal that black metalized body frames reach with 10-14 Celsius degrees lower temperatures than normal black -see figure.5 case f. To understand why the reflection in the color and clear coat is so much important for the aesthetics of the car we present from bibliography [5] same short optical facts.

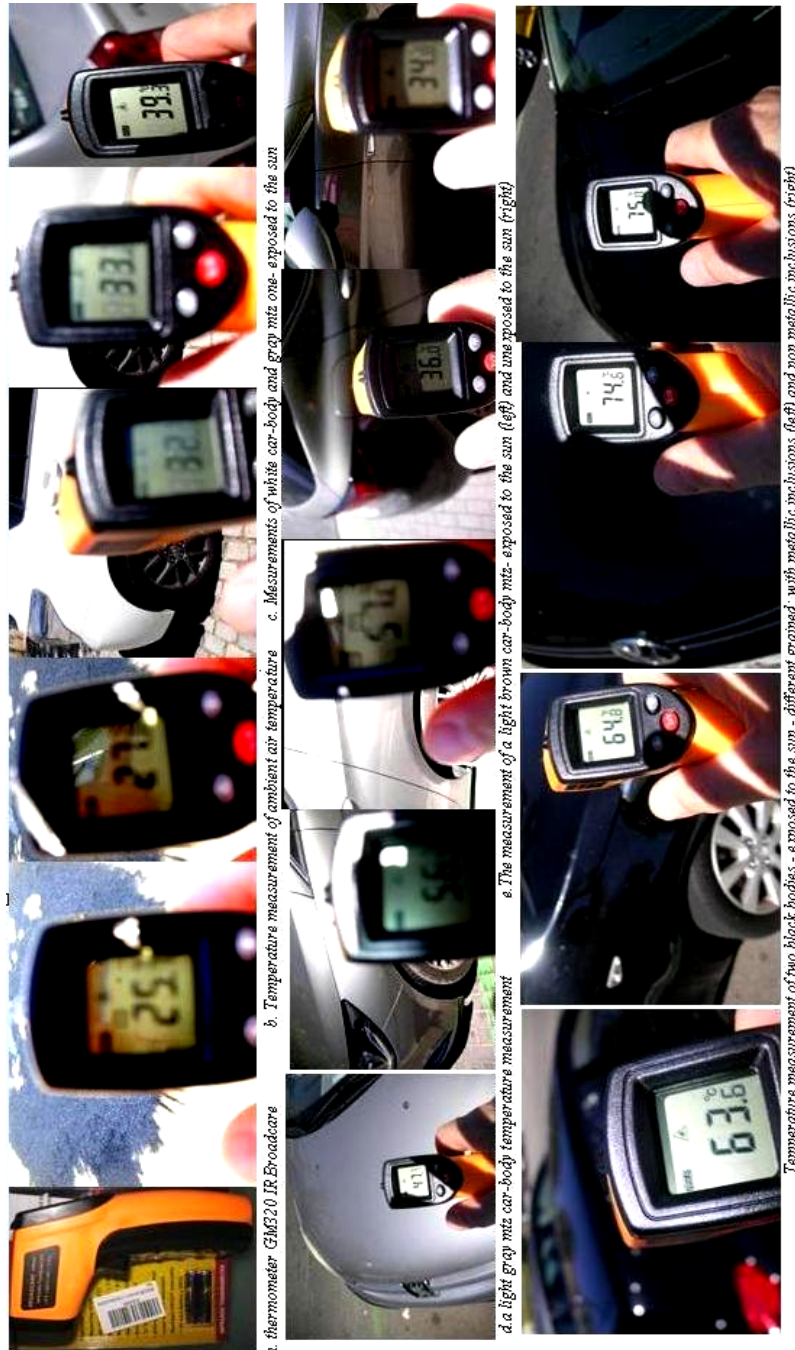
**Fig. 7.** Monitoring the temperature of a car bodyshell in a summer day with ambient temperature of 25-27°C with infrared thermometer Broadcare GM 320
