ASSESSING CUMULATIVE DAMAGE ON RC STRUCTURES BY TEMPORARY SEISMIC INSTRUMENTATION

C.S. DRAGOMIR^{1,2}, D. DOBRE^{2,3}, E.S. GEORGESCU²

Key words: *seismic action, structural analysis, dynamic parameters.*

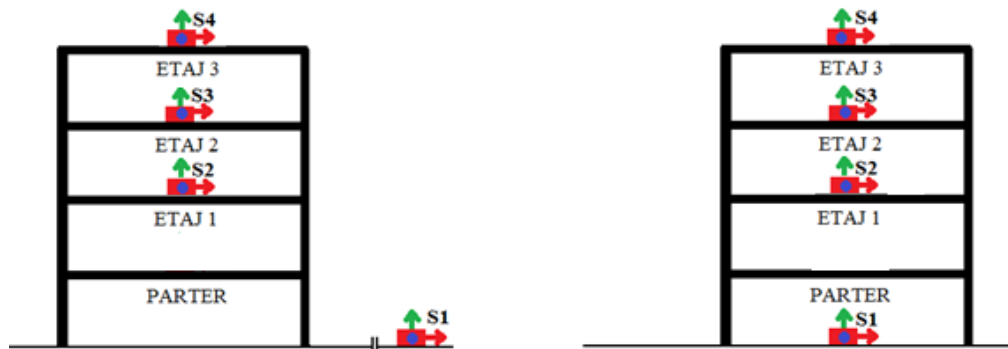
Fig. 1. Sensor placement schemes

Following the above steps, microseism measurements were made on the experimental model, following two sensor placement schemes presented in Fig. 1. Measurements were made both by applying shocks in the centre of the 2nd floor and the microseism movement from the site.

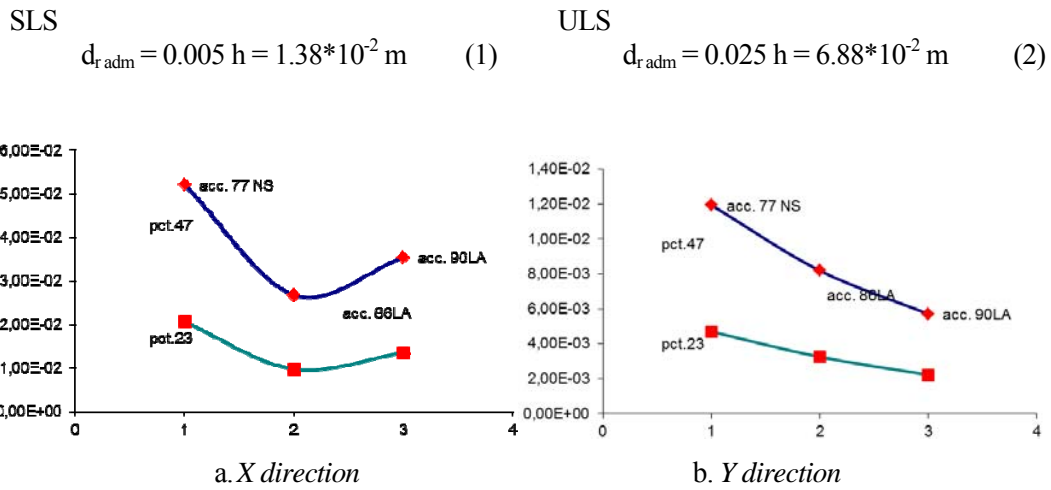
Fig. 3. Maximum values of displacements in the y direction, corresponding to nodes 47 and 23 at different earthquakes ('77, '86 and '90)

The linear modal time-history analysis provides the results as graphs and comprises, for the structural system studied, the movement and acceleration variations versus time, in a node at the top level and at the level 1.

Regarding the movements, the results are shown on Fig. 3 and Fig. 4.

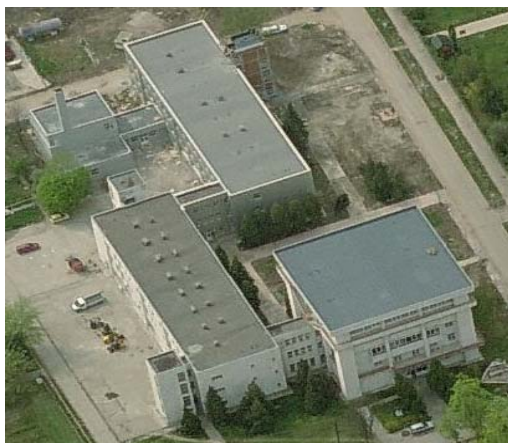
Fig. 4. The Faculty of Land Reclamation and Environmental Engineering in Bucharest

Part of the building of the Faculty of Land Reclamation and Environmental Engineering has resistance structure of reinforced concrete frames designed in the '70s, according to the Code P13-70 (see Fig. 4).

Although the height is low ($H = 20.33 \text{ m}$) and the shape in plane is regular, the

earthquake of 4 March 1977 have caused damage, especially to non-structural elements due to insufficient stiffness for the protection of subdivision elements.

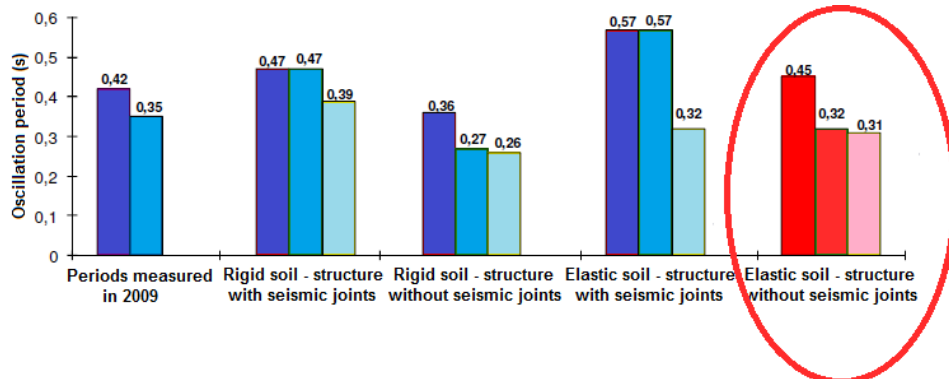
Fig. 8. Oscillation periods of the first three modes obtained from analysis performed in the 4 assumptions compared with recently measured oscillation periods

In comparison calculation were taken into account the two structural assumptions: 1. the parts were separated by virtual seismic joints, and, 2. the parts were linked together without seismic gaps. These assumptions were applied to both rigid and elastic soil.

of oscillation, the comparative analysis shows (Fig. 8) that the real behaviour of the structure corresponds to the elastic structure hypothesis (there is a ground-structure interaction) without seismic joints, which is the real situation at this moment [7].

From the image shown in Fig. 8, it can be seen that the two consolidations have brought an decreases in the period of fundamental mode of oscillation (39% compared to initial version). This demonstrates the effectiveness of interventions to strengthen applied throughout the period of life of the structure, but they have become inadequate because of changes occurring over time

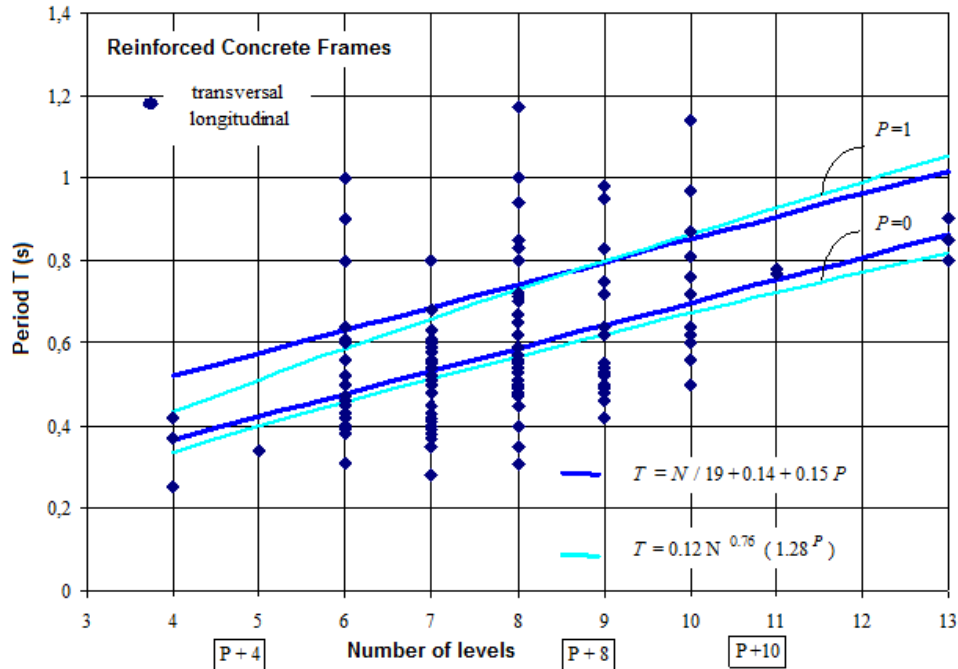
Fig. 9. Periods measured by INCERC for RC structures

In Fig. 9 are shown the periods measured by INCERC for some specimens of the existing buildings of reinforced concrete frame made in Bucharest in different periods.

Two regression models (other than those presented in previous sections): linear and nonlinear (UBC format, Eurocode) are sized. The exponent of 0.76 determined for the reinforced concrete frame structures is closed to value 0.75 specified in UBC and Eurocode8.

$$T = 0,12N^{0,76} = > T = 0,41 s \quad (3)$$
