# The Experimental Analysis and Numerical Simulation of a Car Frame Coating Thickness - Element in a Legal Cause Settlement of an Insurance Proof

**Abstract.** This paper deals with an issue that car owners are facing increasingly more (*after the coatings of car bodies increasingly thinner in the manufacturer's process - for economic and financial reasons*) in the conditions in which warranty complaints relating to the ability of the coating to preserve the aesthetic qualities of the car exterior surface, grow. The theme paper highlights a set of measurements of the car's body element „left rear wing "directly correlated with the reference of an one year earlier similar production car, and draw conclusions through the simulation in a virtual environment, related to the uniformity coating thickness and framing of the car body element / within the limits assumed by the manufacturer - thus identifying potential areas with lower resistance to the aggressive factors of the environment.

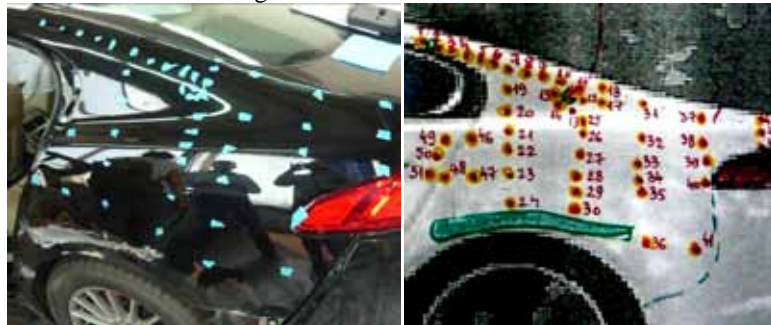
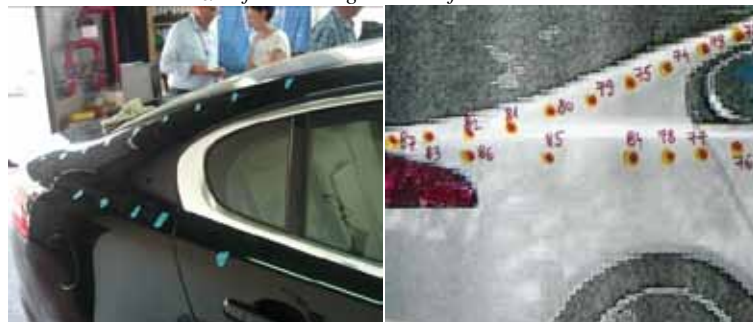
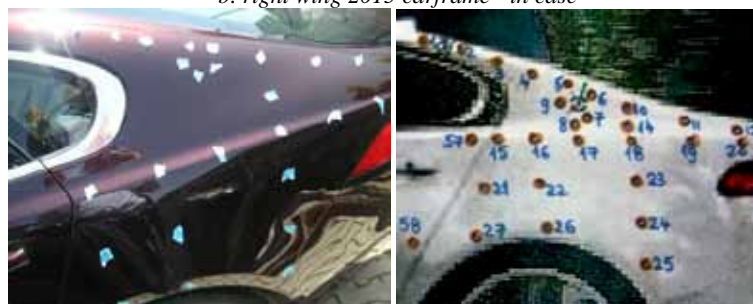
**Fig. 1.** Measuring experimental car body preparation

*a. left rear wing 2015 carframe - in case*

*b. right wing 2015 carframe - in case*

*c. similar left rear wing 2016 carframe -dealer reference*

In Figure 1 we can see the correspondence measurement points relative to the positioning of the measured values (statistically mediation) taken by the team formed by six experts (three technical experts, investigators and three specialists from the brand manufacturer) in connection with the coating thickness of body every measuring point (pre-treatment, undercoating layer of primer + insulator (sealing body) (primer) + paint (base coat chromatic coverage -) + protective varnish) which is modeled virtual (after chromatic tones) by extreme values measured for each component in the three cases in Figure 2: a. left rear wing -car in the case; b . right rear wing- car in the case (1800 rotated to front in Figure 1, b) c. similar car left rear wing 2016production model reference.

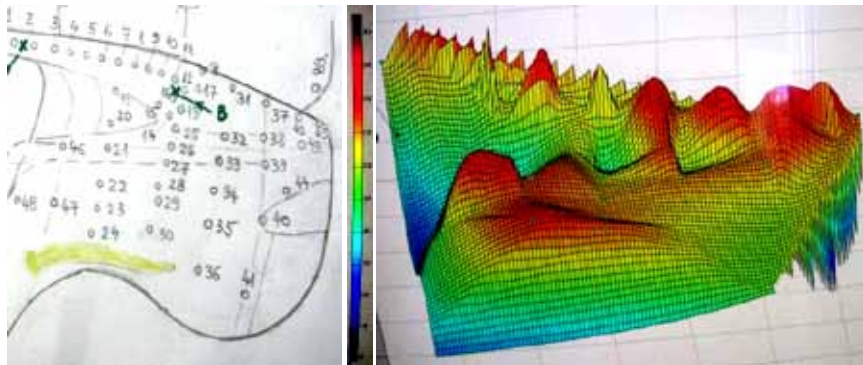
**Fig. 2.** Digitization of framework surface coatings *left rear wing* element of the bodyframe - according to the experimental measurements

Virtual color processing gives us (up-dark red coating thickness of heavy-valued maximum-dark blue heavy-minimum coating thickness values-down on the scale) for the destruction area of interest B fig.2, a particularly important technical feature: „in this area the coating is thinner than adjacent areas” (comparison made in Figure 3 between point a and c-between elements of the body had not suffered subsequent coatings on the manufacturing line -up crossing the final quality control). This shows that it is possible, even due to the design configuration of the shape of the body frame element „rear wing”, or because of the brand’s technology coatings (paint drop granulation, coating robot head tilt, instant pressure design particle paint / varnish, value of the electrostatic field created between body and “ground”) thickness of the coverage remain more consistent towards the upper edge of the body "rear wing" and less in B zone, -the present research focus measurement. Perhaps this is an argument that less consistent coating B Zone may be less resistant to external destructive factor attack. Variant analysis of coating thickness by adding an additional layer of color paint and clear coat shown in Figure 3 (bright rear wing of the car in case - rotated 1800) confirms this argument : in the terms of additional coverage "settlement coating on the rear wing support" behavior determine coating thickness decrease in the same area studied symmetric versus B zone of the left back wing;

However, this observation should be added that the coating in the cases studied and modeled in 2 and 3 are a and b (when the coating thickness was not influenced by - repair coatings, paints, and subsequent clear coatings-) represented paint thickness values for the relevant passenger car-production in 2015, falls within the general engineering supported documentary producer that set the margins, between 79 microns and 526 microns.

Because the B-zone fig.2 is the research area in which has been claimed an aesthetic destruction appeared to the body coating turned out, the experimental measurements made here revealed lower paint coating than in adjacent areas, partly because of the design surface configuration and layout of body parts, partly probably due to plant manufacturer technology coverage, but with the final thickness of the entire protective coatings of the car frame was found within the limits declared by the manufacturer. The result of the forensic research was that the complaint made during the warranty period on these issues was unfounded and therefore rejected.

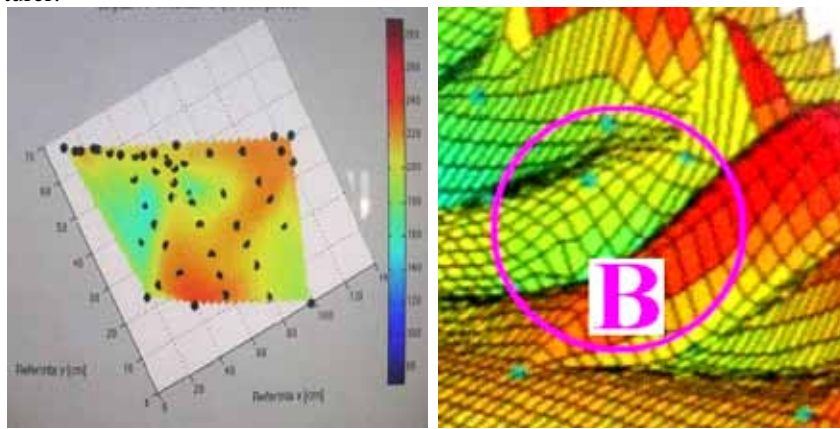
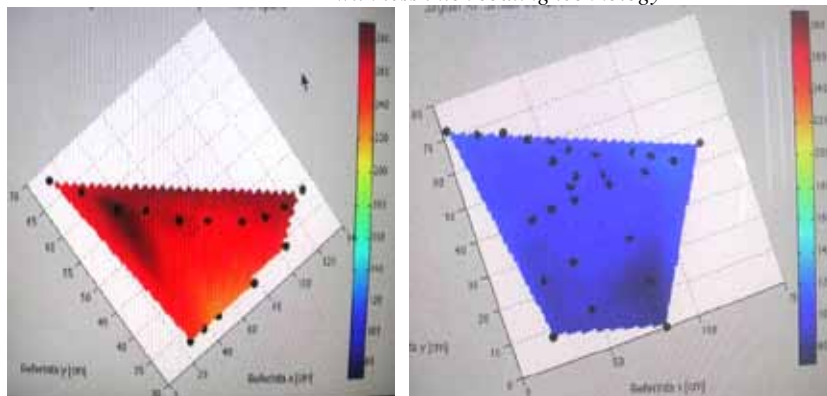
**Fig. 4.** Distribution of the coating thickness between maximum and minimum measurements on the frame element rear wing get through virtual simulation in MatLab mathematical software in order and compare coating thickness with manufacture's technical limits: 79-526 $\mu$ m

a. Left rear wing car in the case – 2015 plant coating bodyframe surface layer "for zone B with less thick coating technology"

b. right wing car -rotated front with 180° - extra layer of coverage (repair)

c Left rear wing car reference 2016 thinner layer on the (Al) support deposited on the 2016 production line, in the plant

To get a clear picture of the destruction scale of the car frame part "left rear wing Area B (Figure 4) " of the 2015 production car – in case -, was imposed, in virtual environment, the same level of scale representation (of course with MAXimum thickness coating recorded for the analysis of the right rear wing (-documented repainted after the damages suffered in an accident), and the MINimum recorded in the measurements of body car reference / 2016 -left rear wing- (car provided by the manufacturer's representative - see Figure 1,c, and Figure 2,c), virtual data experimental results (in Figure 4,a,2) confirming the results already iterated above.

An interesting observation it appears when we find, experimentally that the non-ferrous (aluminum base) body frame car technology coating can reduce drastically in terms of thickness values and depth of cover, with primarily financial and economic implications, for the manufacturing company. But it is possible that the type of paint, its viscosity, texture and pigment-based combination, setting technological parameters of robotic paint line for painting non-metallic version (as in our research case) Figure 1, a, b and Figure 3 a, b, or metal coatings (as in the case of the car having as a reference –Figure 1.c and Figure 3,c) determine the possibility of one year later covering body parts "left wing back" below the limit of 79 micron, declared by the manufacturer.
