INTERNATIONAL SCIENTIFIC CONFERENCE

CIBv 2010

ASPECTS REGARDING INVESTIGATION AND CONSOLIDATION OF SITE ARRANGEMENT OF RESIDENTIAL BUILDINGS

Abstract: In this paper the authors presents the causes, forms of manifestation, methods of investigation and solution for consolidation of the site arrangement of residential buildings that was affected through degradation of existing retaining wall.

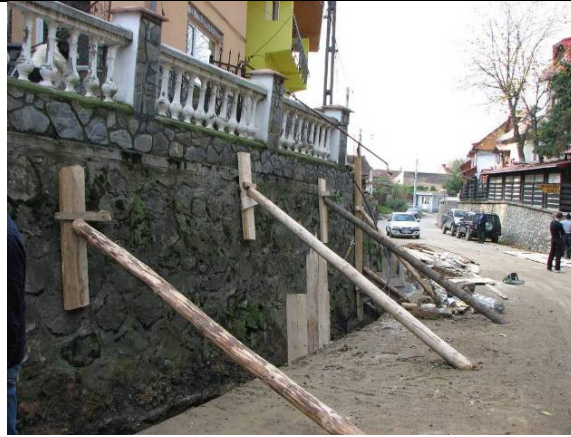
The lack of passive resistance of the earth located downstream of the retaining wall [3], [4] as a result of the digging carried out near and under the foundation quota, on long sections (fig. 2), led to linear and angular shifts of the wall, highlighted by cracks whose opening reaches to 10 cm.

Fig. 2 The digging carried out on long sections near and under the foundation quota of the retaining wall

Sewage works carried out near and under the wall lead altered the strength and stability of a section of the wall and of the related soil.

The status of degradation was determined mainly by the digging works on the main domestic sewage collector, carried out near and under the implantation quota of the retaining wall and left open on relatively large length, for a certain period of time [1].

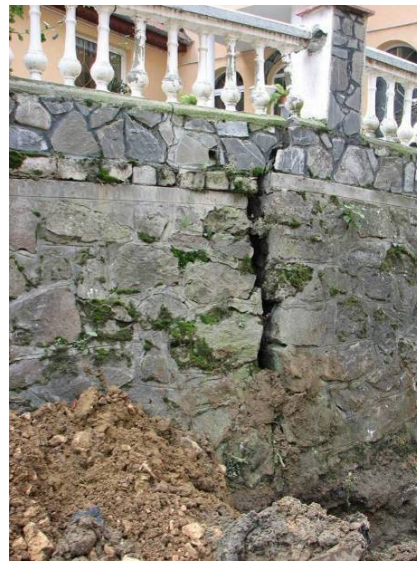
The opening of cracks formed in the area is accentuated in the area of the compression joint on the wall height, but cross also the support area of the protection bulwark achieved subsequently (fig. 3 and 4).

Fig. 3 The large opening of the compression joint

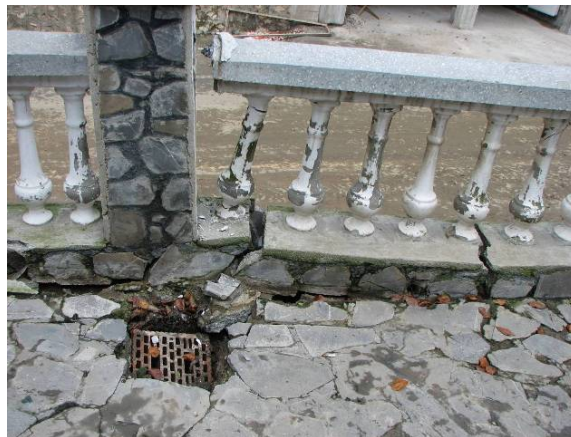
Fig. 4 Cracks in the protection bulwark area

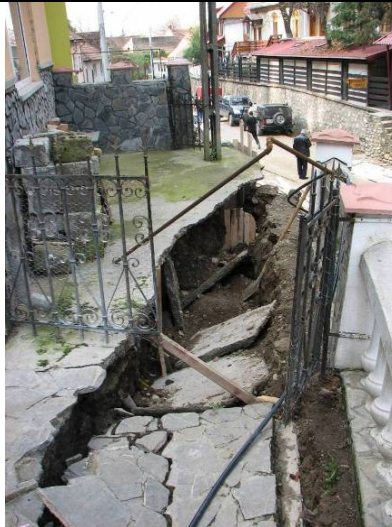
The linear and angular movements of the portion of the wall bounded by serious cracks have generated their separation from the wall and trigger of land portions expanding to the existing buildings (fig. 5).

Fig. 5 Crashing of portions of land behind the retaining wall

The forms of manifestation of the presented degradation highlight the retaining and stability capacity of the retaining wall affected as a result of the sewerage works [3].

To restore the newly created situation, emergency measures are required aimed at restoring the strength and stability condition of the retaining wall affected following the sewerage works.

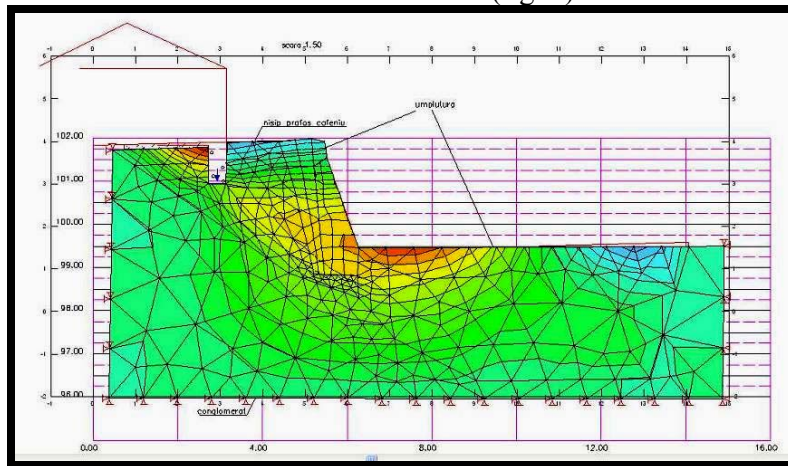
- In the initial stage 1 the unitary horizontal efforts considerably increase in the area next to the neighboring building foundation, figure 7 without this, however, being affected, and the maximum horizontal displacement of the bulk land reaches 3.2 mm (fig. 8).

Fig. 7 Distribution of horizontal efforts in the ground next to the neighboring building at the initial stage
