# CASE STUDY ON STRUCTURAL REHABILITATION OF A DAMAGED WING OF A BUILDING, IN ORDER TO CHANGE DESTINATION

**Abstract:** *This paper presents a case study made on an existing building, with reinforced concrete frames as structural resistance system and masonry walls, which have obtained an advanced state of degradation. The proposed consolidation solution leads for obtaining a seismic insurance degree that fits the requirements imposed by the P 100-2006 normative.*

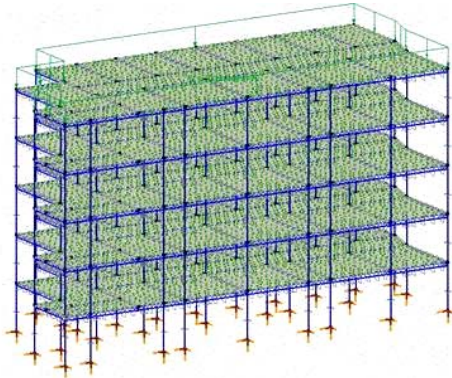
Fig.7. The load form of the structure in the structural analysis program AXIS

The calculation method was applied on the current model of structure, studying the wing B1 of the building.

It was used the structural analysis program AXIS, and applying the loads determined at point 1.3, properly (according to technical rules now available for loads), Figure 7.
