Diagnosis of the Unit Injection Pump's Elements

Abstract. The paper presents the experimental and technical steps for diagnosis and optical investigation of the unit injection pump's elements for light and heavy diesel trucks, in order to establish the causes of malfunctioning and decision of replacing and/or repairing them. There will be presented some of the most usual damages and technical explanations and interpretation of the diagnosis tests.

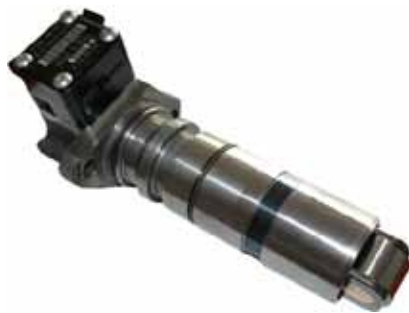
Fig. 1. Bosch Unit Injection Pump (UIP)

In these conditions, the whole attention was concentrate on the six unit pumps, as the most important part of the injection system that could generate working inaccuracies. In Fig.1 is presented one of the injection pump unit (UIP), which was tested for

working parameters (injection pressure, pressure drop, leaks, flow, etc.). All the six UIP were tested individually, in order to precisely identify the whole problems of the injection system.

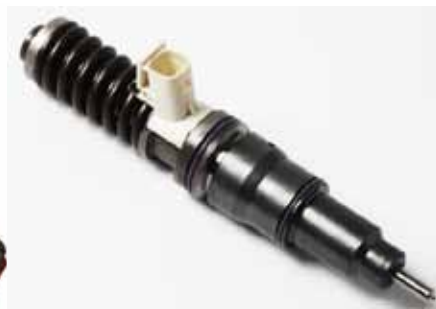
Fig. 2. Delphi Electronic Unit Injector (EUI)

The tested D12D diesel engine of the Volvo FH 42 truck (12.130 ccm, 309 kW, Euro 3, 2005 year) was equipped with six Delphi E3 Electronic Unit Injectors (EUI), Fig.2, and the symptoms claim by the owner consists of impossible normal start (only with additional volatile substances injected/sprayed in intake pipe), variable idle speed and poor performances (power/torque). The injection system works at high pressure (maximum around 2500 bar) and the “mechanical” parts are controlled through an electronic control unit (ECU) of the diesel management structure. As a whole assembly, consisting either of high pressure pump but also with the valve-nozzle injector unit, the possible damages that distort the working parameters must be separated, and each part must be distinctly diagnosed.

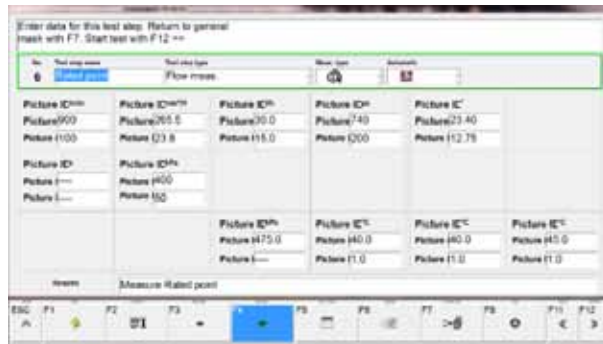
Fig. 3. Working parameters for flow measurements

Because the working condition refer also to the flow measurement, there were performed such tests on EPS 815 test bench and were followed up multiple parameters and demanding conditions requisites, for example fuel/conditioning oil temperature, pressure, flow on different conditions (start up point, warm up, clean run, conditioning, rated point, cooling). All these parameters were directly acquired and analyzed through specific interface of the test bench and some of this information, for rated point measurements, is presented in Fig.3.

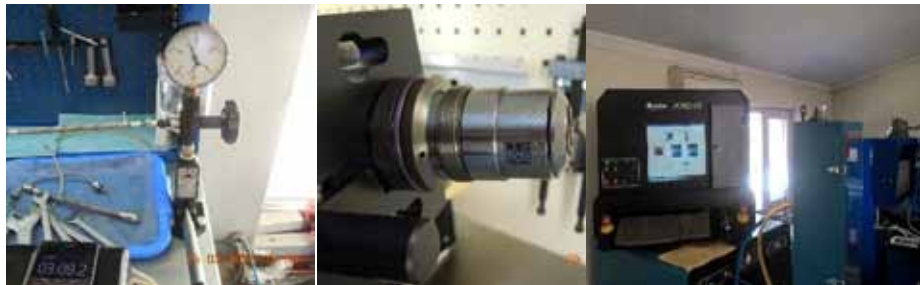
Fig. 7. Pressure drop test

T3. Back Leakage – BL, that reveal the period of maintaining the drop of pressure between 170 to 140 bars, inside the nozzle. Optimum period of the pressure drop must be in 3 – 30 s range;

Fig.7 presents the testing device for pressure drop measurement of the nozzle, Fig. 8 presents the special unmounting/mounting device of the EUI and an EUI body (consisting of hydraulic body, valve, electric coil, a.o.) and Fig. 9 presents the Hartdrige AVM 2 – PC -20hp test bench, prepared for EUI test.
