INTERNATIONAL SCIENTIFIC CONFERENCE

CIBv 2010

PROPOSAL FOR THE REHABILITATION OF AN OLD STEEL BRIDGE AT DUMBRĂVENI, COUNTY SIBIU

Abstract: This paper presents the study of an old steel bridge in Dumbrăveni over the Târnava Mare River, in order to rehabilitate it. The structure was recalculated taking into account the technical condition of the bridge and the actual traffic as well. Finally, a pleading is made for maintaining the over 80 year old historical bridge and several proposals are being formulated for the rehabilitation.

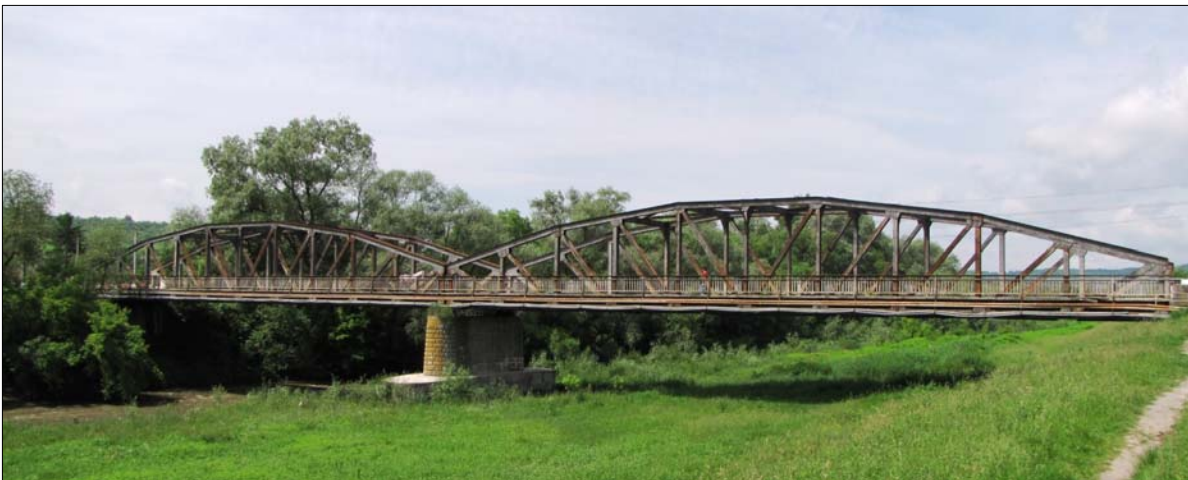
Fig. 4 General view of the bridge in Dumbrăveni

The general behaviour of the bridge is satisfactory. The lower part of the bridge is affected by corrosion and the maintenance of the bridge is unsatisfactory and un-continuous. The bridge is under the responsibility of the town hall of Dumbrăveni, a city with a population of a little over 12000 inhabitants in the county of Sibiu, in the centre of Romania.

The width of the carriageway is 5.43 m, corresponding to a single lane. There is only one footway, placed on the downstream main girder having a width of 1.4 m. The deck consists of a series of stringers and cross beams, with a concrete plate with the thickness of 20 cm. The maximum height of the main girder is 6.18 m, corresponding to a ratio $L/H = 1/7$. All the connections are riveted.

- Unveiling of the concrete plate
- Sandblasting of the structure
- Changing of the high corroded elements
- Realization of on concrete plate with a composite concrete-steel effect

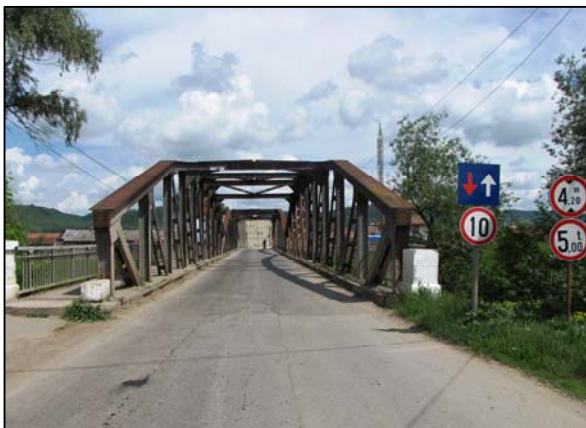
Fig. 6 Front view

The struts of the cross girder are formed from a 300x10 web and four angles (LL 120x80x12, LL 20x80x10, LL 100x75x9 or L 80x80x10) and diagonals' cross section consist of four angles (LL 120x80x10 or LL 100x75x9).

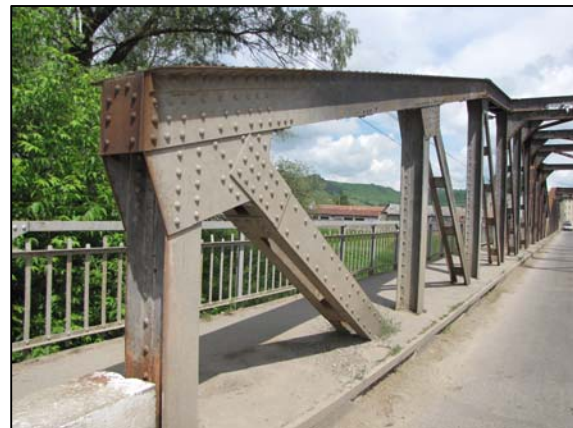
Fig. 7 Main truss girder

Each deck is supported by four bearings, two fixed and two mobile. Across the bridge there are four fixed and four mobile bearings. The maintenance of the bridge is poor and the elements of the structure are more or less corroded.

Least affected were the elements that allowed the drainage of the water – the struts and the diagonals. The most affected structural elements are the lower chords, the stringers and the cross girders.

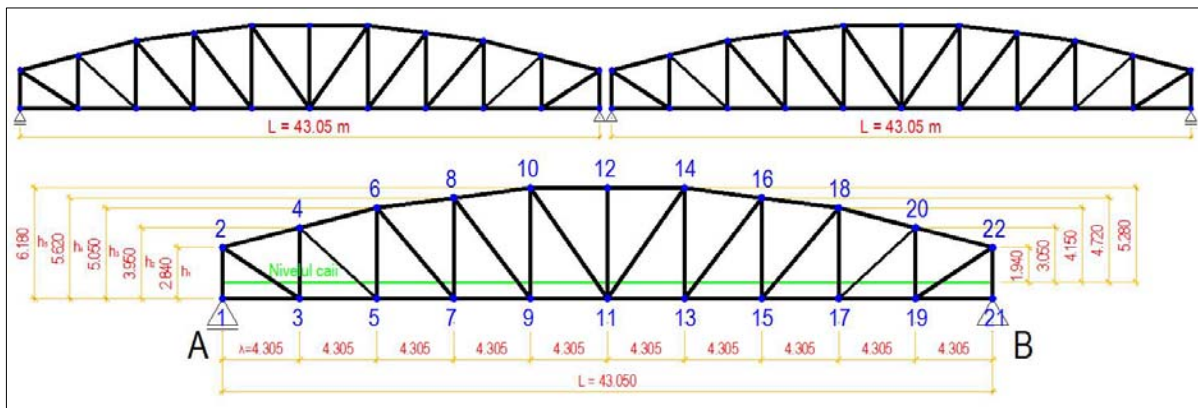
Fig. 10 Static scheme and dimension of the truss girders

The bar tensions have been calculated using analytical influence lines. The dead loads have been estimated on the basis of the measured element geometries and material properties.

The allowable stress according to the standards, for load case 1, is $\sigma_a=150 \text{ N/mm}^2$. The values of the stresses in the upper chord exceed the allowable stress; therefore the bridge is not to be crossed by these convoys.

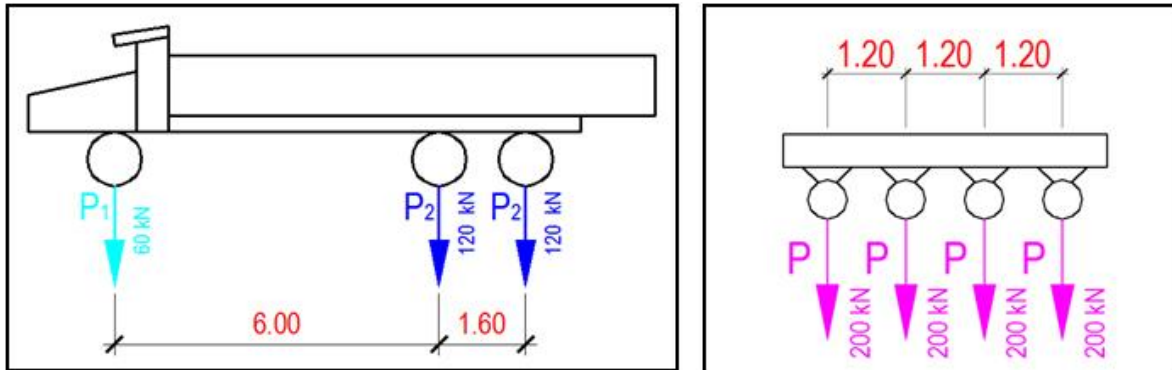
Fig.11 Vehicles of the A30 and V80 convoys

The verified convoys, according to the standards and corresponding to the load class E, were the A30 – 30 tonne truck convoy and V80 – special 80 tonne military vehicle (Figure 11). The distance between the A30 vehicles is 10 m and the V80 convoy consists of just one vehicle.

- Trucks over 30 tonnes are strictly forbidden.
- Annealing of the road surface on the bridge in order to eliminate the defects that lead to high dynamic coefficients and important damages to the structure

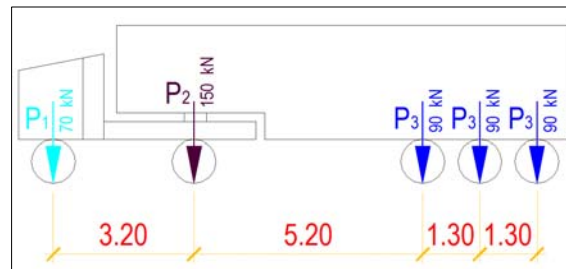
Fig.12 A49 vehicle

According to the National Road Administration, a 49 tonne truck can occur relatively often in Romania. So the structure was verified for a single A49 vehicle, too (Figure 12).
