INTERNATIONAL SCIENTIFIC CONFERENCE

CIBv 2010

12 – 13 November 2010, Braşov

EXISTING CONCRETE SILOS – LESSONS FROM INSPECTION, DIAGNOSIS, REHABILITATION AND STRENGTHENING

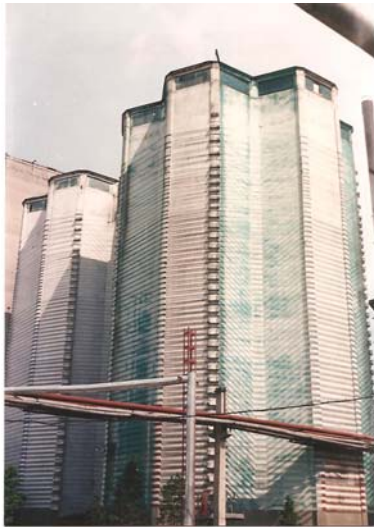
The two coupled soya beans silos from the oil factories in Buzau and Urziceni consist of seven hexagonal cells each (figure 1). The side of each hexagonal cell is 3.75 m and about 32 m in height. Figure 2 presents a horizontal cross section.

Fig.1 View of coupled silos

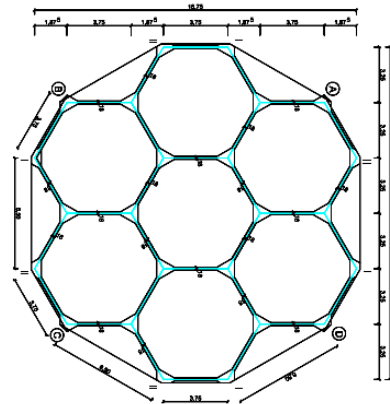
Fig.2 Cross section of hexagonal silo

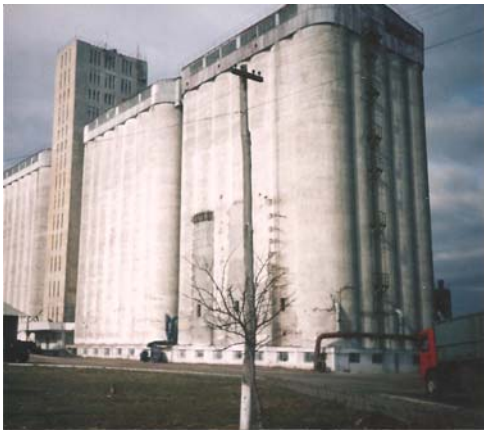
The first grain silo from Urziceni storage base built 25 years before the inspection is composed of three batteries of 12 cylindrical cells, one cell of 7 m in diameter and 36 m in high, with the wall thickness of 18 cm. The slip form method of construction was used .

Multiple deteriorations, especially noted in one battery, mainly affected the concrete cells wall, having an advanced state of cracking and numerous deficiencies, such as lack of compactness, due to the slip form method of concrete walls construction.

Fig.13 Urziceni silo

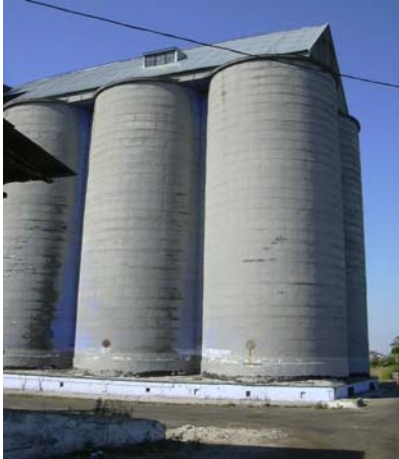
The second silo from Dragos Voda storage base, built 40 years before the inspection is composed of 6 cylindrical cells, one cell having a diameter of 7.30 m and 20 m high, with a wall thickness of 15 cm. Two stellate cells are formed between the cylindrical cell walls.

Fig.15 Dragos Voda silo

The main deteriorations of this silo were observed to concrete and reinforcement on external cells surface only.
