# **Analysis of the Car Bodywork Protective Coating's Destruction in Contact with Marine Bird Droppings on the Black Sea Coast**

**Abstract.** In the paper we take in considerations some possibilities of identify, based on a "template or pattern visually determined" the car bodywork protective coating's destruction in contact with marine bird droppings on coast zone - referring directly to a specific panel of a premium body frame manufacturer – where, through experimentally searching reporting referential and systematic precision measurements of coating thickness in the affected area, we shape the deformation of the coating and simulated it in a virtual environment, highlighting possible causes of the loss of the aesthetic qualities protection of the car-body-frame film layer.

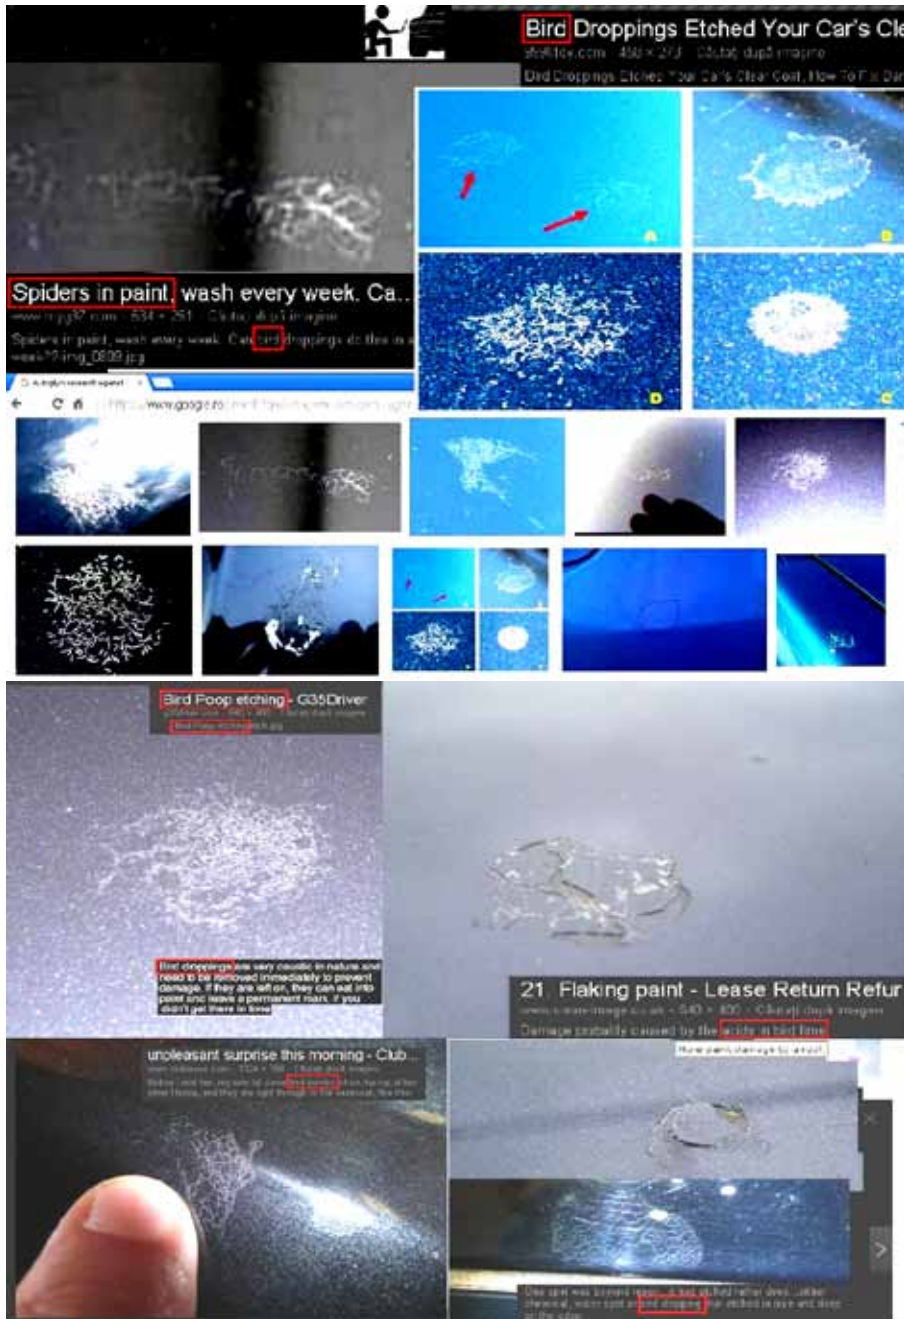
Appendix 1 Photos of the aftermath impact of bird droppings ("Bird droppings, bird-poo") and coating surface of car bodyframe Source: [www.AutoGlyme.com](http://www.AutoGlyme.com)

The related image's documentation available in the bibliography and in other video and photo documents from the Internet (*whose content was selectively presented in Appendix 1*), show that the interaction of bird droppings over the covering film coating of a car body resulting can be compared with a form of destruction or „a pattern - spider web type -" as the the owner of the car in question complained on In the court relating with its left rear wing (*Figure 2 b*) damage. In this stage we can advance the following observations:

Studied bird droppings in contact with the car body coatings have been proven harmful for varnish and paints, causing fading and even degradation in depth the film coverage of the bodywork (Figure 2 versus Appendix 1) effects amplified by: maximizing the time of reaction (destruction can occur within a few hours of action, so it is extremely important to remove rapidly the deposits from the surface of the body), grain, manure and water content there of (as the grain is bigger the deposit becomes more rigid and if it not removed during the night cool of the frame, it becomes a solid around which clear coat and paint shrinks, the paint taking the form of a cone or a "spider webs" . One it consider as a "typically damage attack of bird droppings on car frame /see Figure 2) "body temperature during the impact, body color, the thickness of the coating film of the car-frame, thickness of the frame panel and its positioning in relation to the sun (prior to the impact with the corrosive substance);
