**The 40th International Conference on
Mechanics of Solids, Acoustics and Vibrations &
The 6th International Conference on
“Advanced Composite Materials Engineering”
COMAT2016 & ICMSAV2016
Brasov, ROMANIA, 24-25 November 2016**

FATIGUE CRACKS INTERACTIONS IN ALUMINIUM ALLOYS

***Abstract:** This paper is concentrated on some microstructural issues concerning the mechanical interactions between fatigue cracks and microstructural constituents of an aluminium alloy subjected to fatigue cycles. A diffusion process involving different manganese compounds developed within the immediate area of the fatigue cracks has been also revealed.*

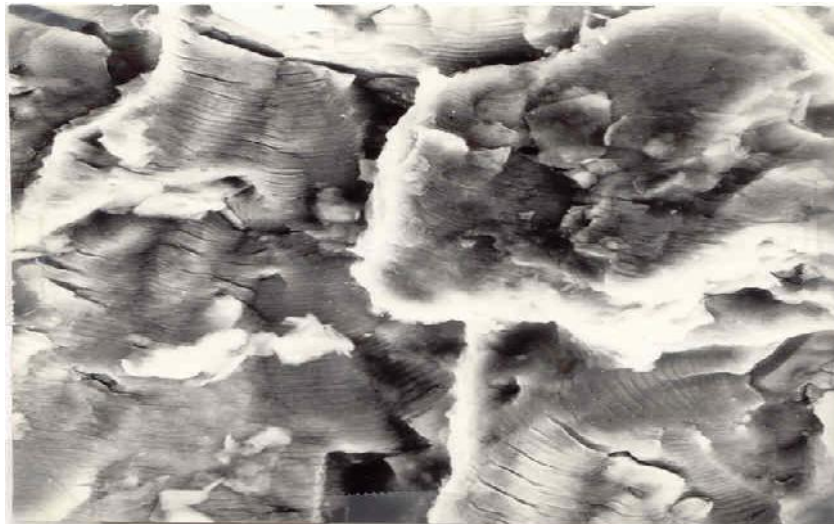
Figure 1a: A fatigue crack surface in Al-alloy

The present-day fatigue research is concentrated on materials cracks behavior, considering that such cracks are present to some degree in all mechanical structures. They may exist as basic defects in the constituent materials – assimilated to material deficiencies in the form of pre-existing flaws – or they may be induced in a certain engineering structure during the service life. In Fig. 1a a fatigue crack surface in Al-alloy has been represented. The whole life time of a certain structure subjected to fatigue cycles (or to static loads as well) depends upon the way in which material cracks do propagate until the final failure. In Fig. 1 and Fig. 2 two fatigue crack surfaces

have been represented. It is to be noted the direct influence of the fatigue crack propagation on the material grains structures. This is why the fatigue phenomenon gives a great importance to the interaction between the fatigue cracks and the microstructural constituents of the investigated alloy. A direct and an important consequence of such a position is that Miner’s linear criterion of damage mechanics loses its validity.

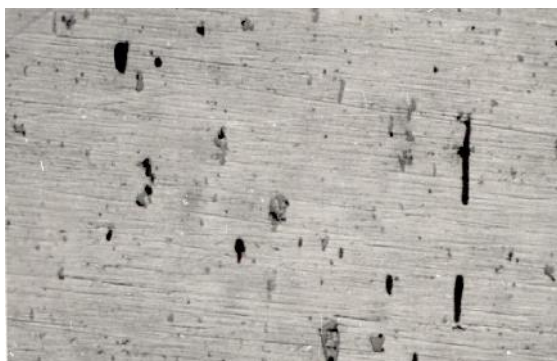
Figure 4: Microstructure of Al 6061 T651 (x300)

In Fig. 4 and Fig. 5 the structures of the considered aluminium alloy, before subjected to fatigue cycles have been represented. In Fig. 6 different types of fatigue cracks interacting the microstructural constituents of the investigated aluminium alloy have been presented. For a small number of fatigue cycles the cracks produced may be very fine and short ($\sim 0.04\text{-}0.07\text{mm}$) - propagating along a single direction (Fig.6 a,b) or may be short and rough, with a bifurcation at end (Fig.6c). One may also notice that in Fig. 6a the crack stopped in its interaction with an above presented chemical compound. There are also cracks which are fine but long (0.1-0.3 mm) that usually propagate at the level of inter-granular area, following the grains borders and passing through the fine precipitated compounds or rounding the components.

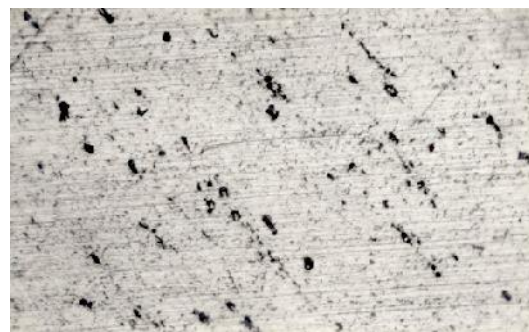
Figure 5: Microstructure of Al 6061 T651 (x300)

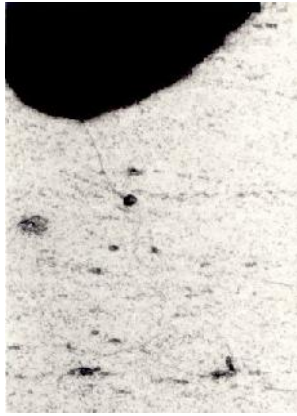
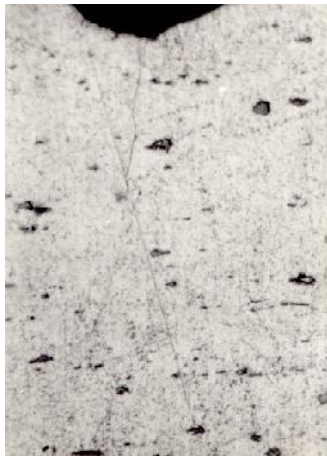
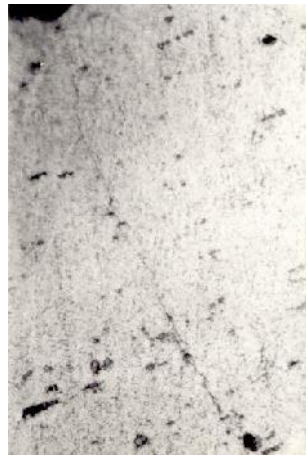
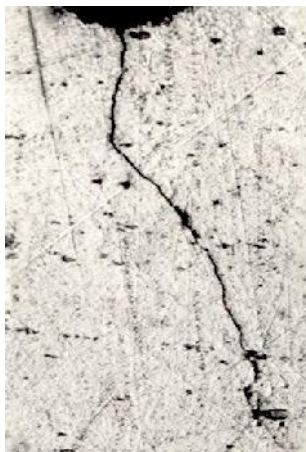
Figure 6: Mechanical interaction between fatigue cracks and microstructural constituents

In Fig. 6d,e,f it is to be noticed that the crack propagated along the direction with an increased chemical unhomogeneity. For a large number of fatigue cycles the cracks are long, thick and linearly propagated (Fig.6 g,h,l) or present short bifurcations when meeting a structural constituent. In Fig. 6h,i,j,k one could observe that the crack does round the chemical compound in form of Chinese letter – identified as being $Fe_3Si_2Al_{12}$ and shown in Fig. 4i. At the same time, different manganese compounds have been observed at the level of the investigated fatigue surfaces that could be the result of a diffusion process involving different one-dimensional faults (interstitial atoms, foreign atoms, second-phase particles etc.) with very important consequences for the fatigue crack propagation and short crack growth (Fig. 6f).
